**INVITATION FOR PROPOSAL #03-24-30028
Bremerton Marina Underwater Inspections**

Addendum 1, 11/13/2024

BREMERTON MARINA BREAKWATER

USS TURNER JOY - MOORING SYSTEM

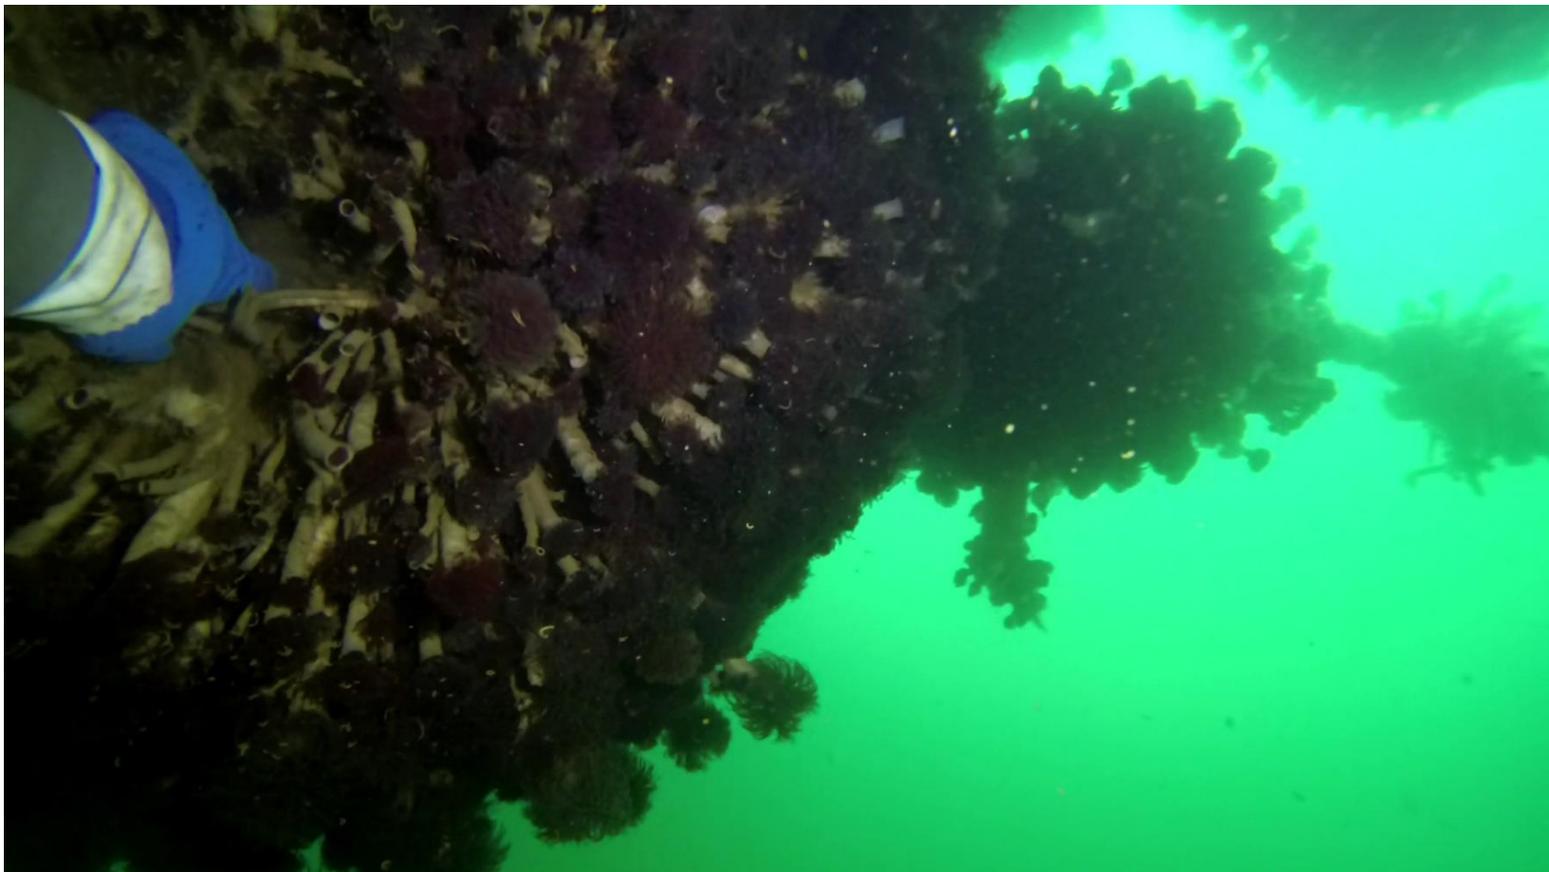
The underwater components of the floating breakwater associated mooring system, connections, and cathodic protection are overall in **Fair** condition. The mooring lines are generally covered in heavy marine growth. The upper chains are typically completely covered in large tube worm colonies which limits visual inspection capabilities and utilizes a tactile inspection. The cables have approximately 80% surface coverage of anemones and barnacle growth. The bottom chains and anchors have approximately 50% surface coverage of anemones and other hard growth. The anodes were generally covered in 50% hard growth but this varied from 0%-100%. (See photos 1-4)

Photo 1: Line 3 - Typical top chain marine growth

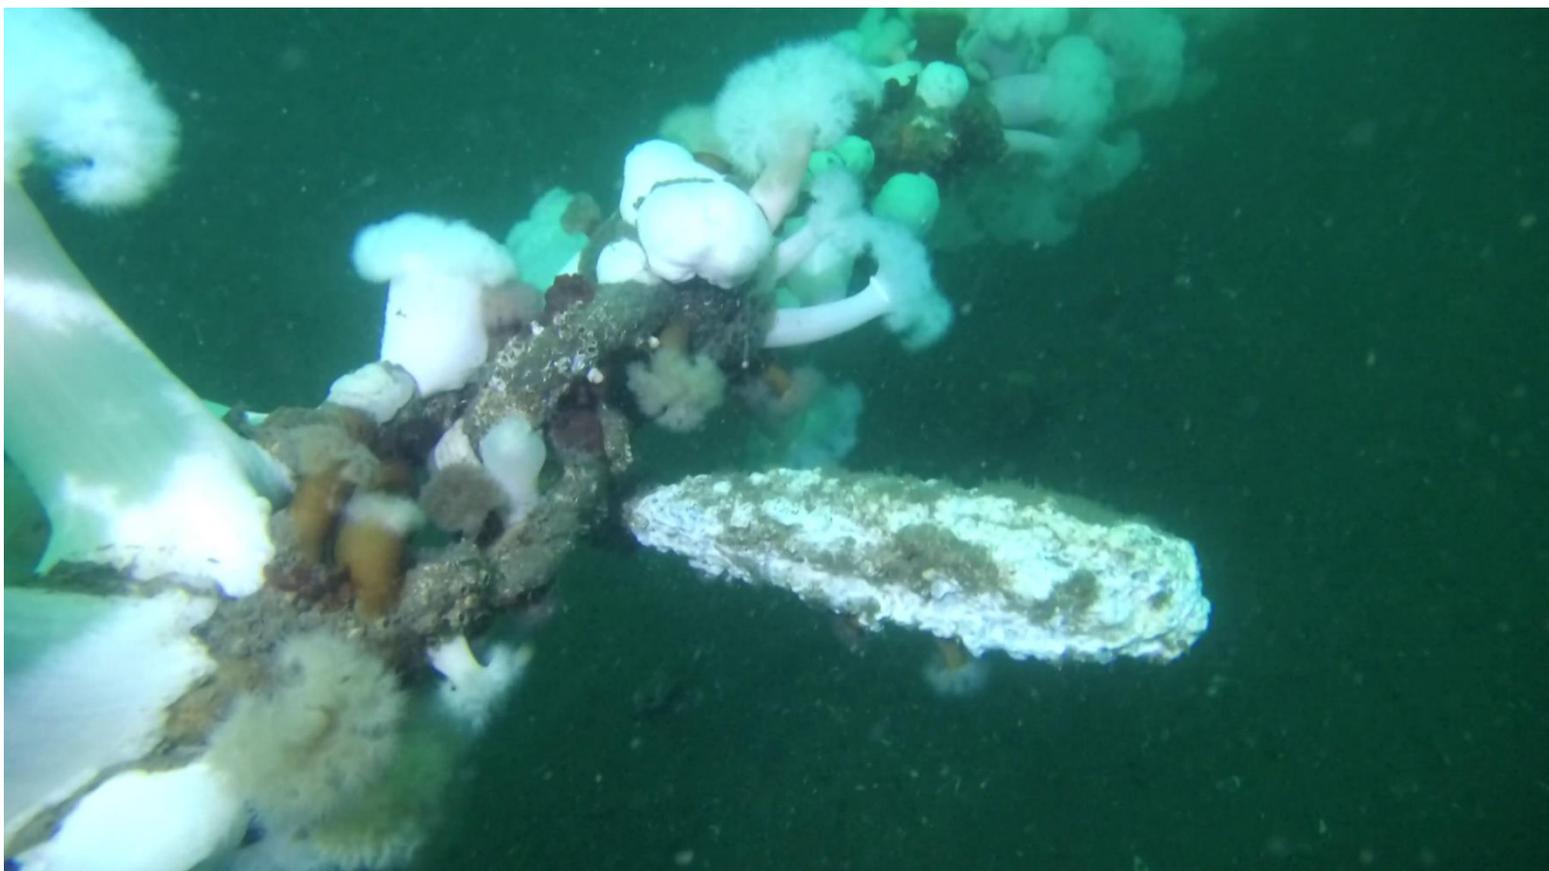
Photo 2: Line 1S - Typical bottom chain condition

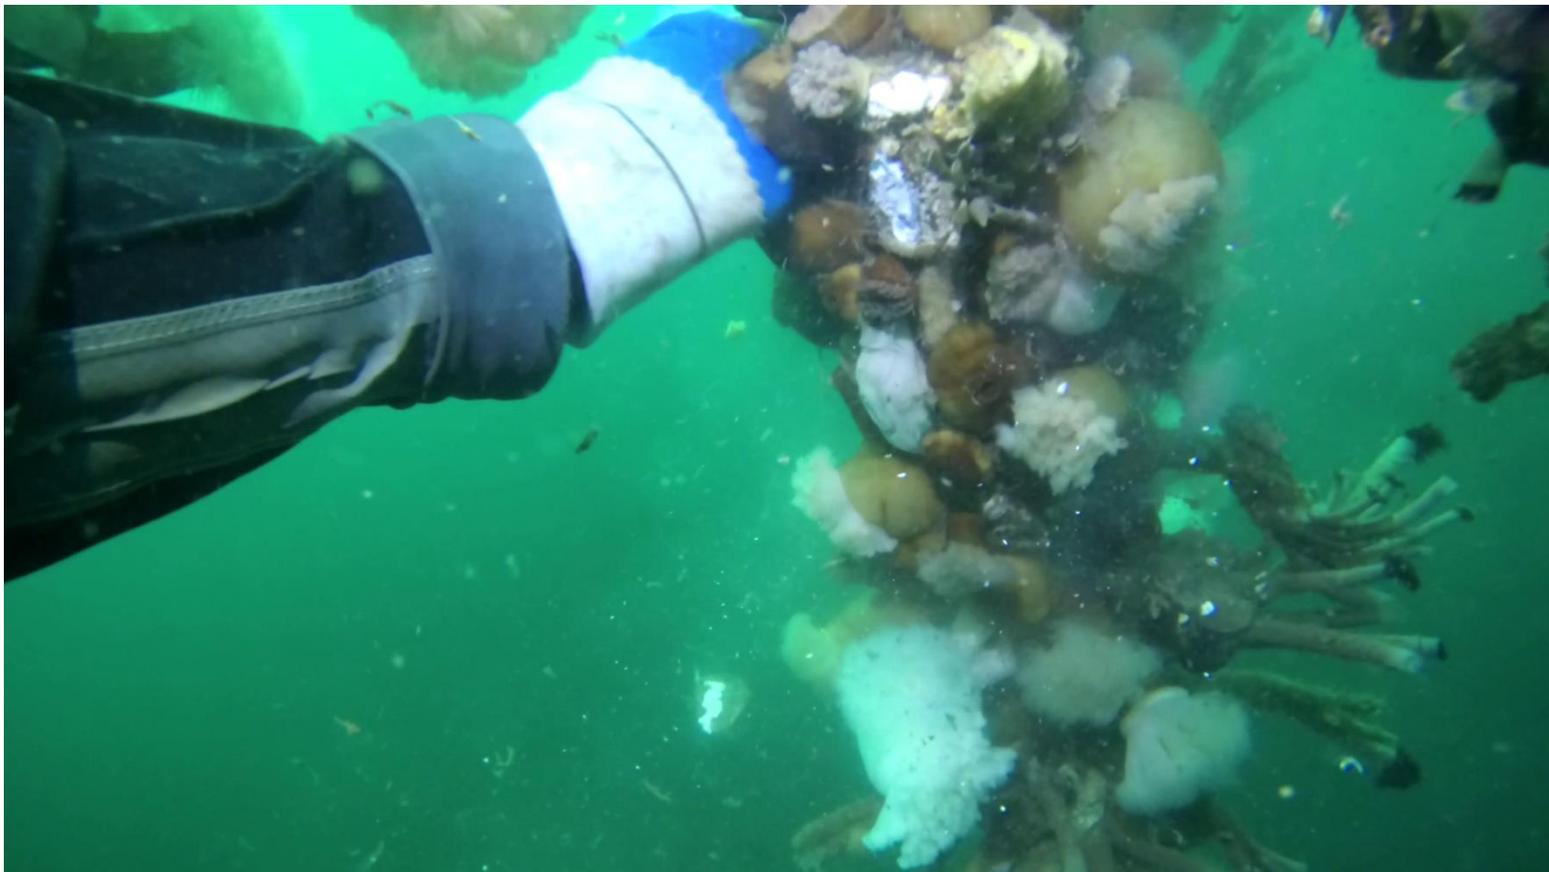
Photo 3: Line 1N - Anode with 100% marine growth

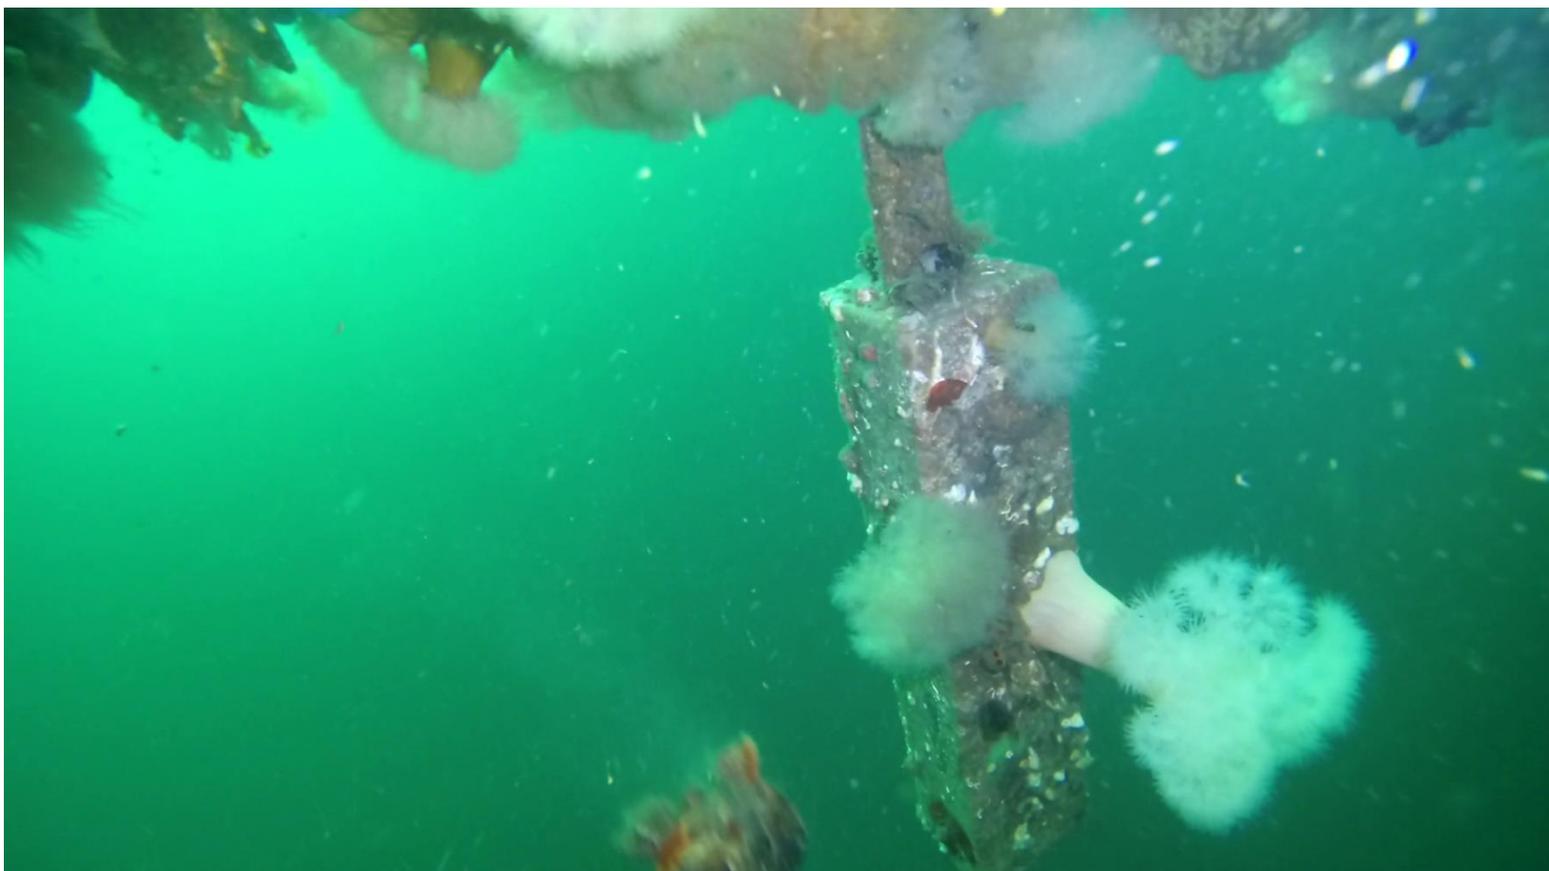
Photo 4: Line 20N - Anode with minimal marine growth

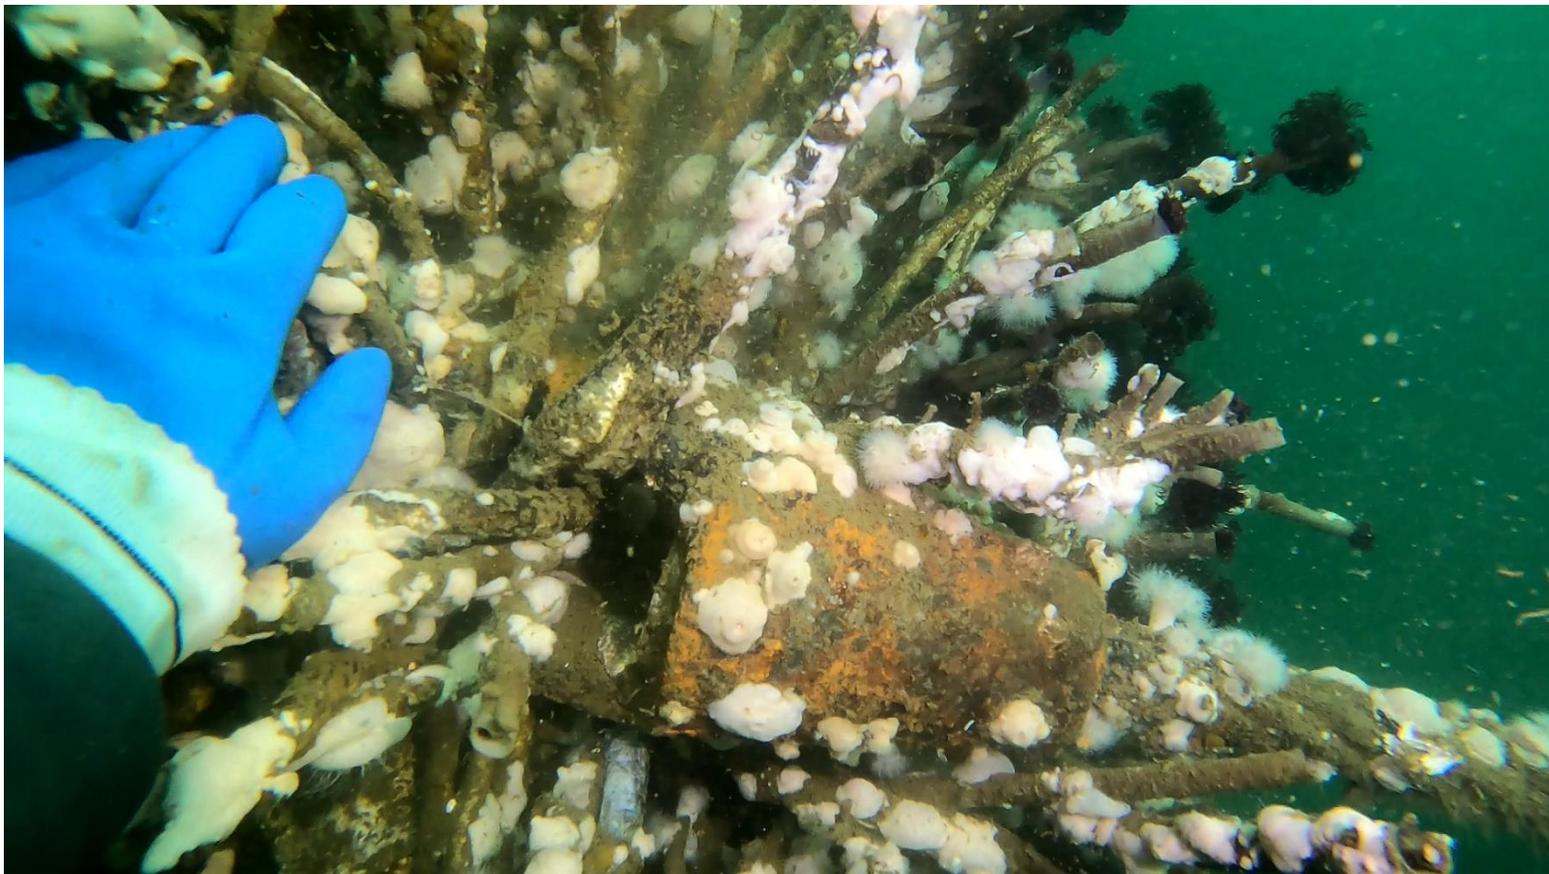
A typical mooring line in Fair condition consists of little to no surface corrosion, no deterioration, with more than 90% of the galvanizing still intact on any visible surface area. Roughly half of the mooring lines have at least one section encased in black surface corrosion or have surface rust throughout the mooring line. When the black corrosion layer was chipped away, it revealed minor surface deterioration. The same conditions were present when the surface rust was brushed away. There was typically <10% material loss on the cables and top chains, and <20% material loss on the bottom chains. (See photos 5-9)

Photo 5: Line 18 - Surface rust on top cable eye socket

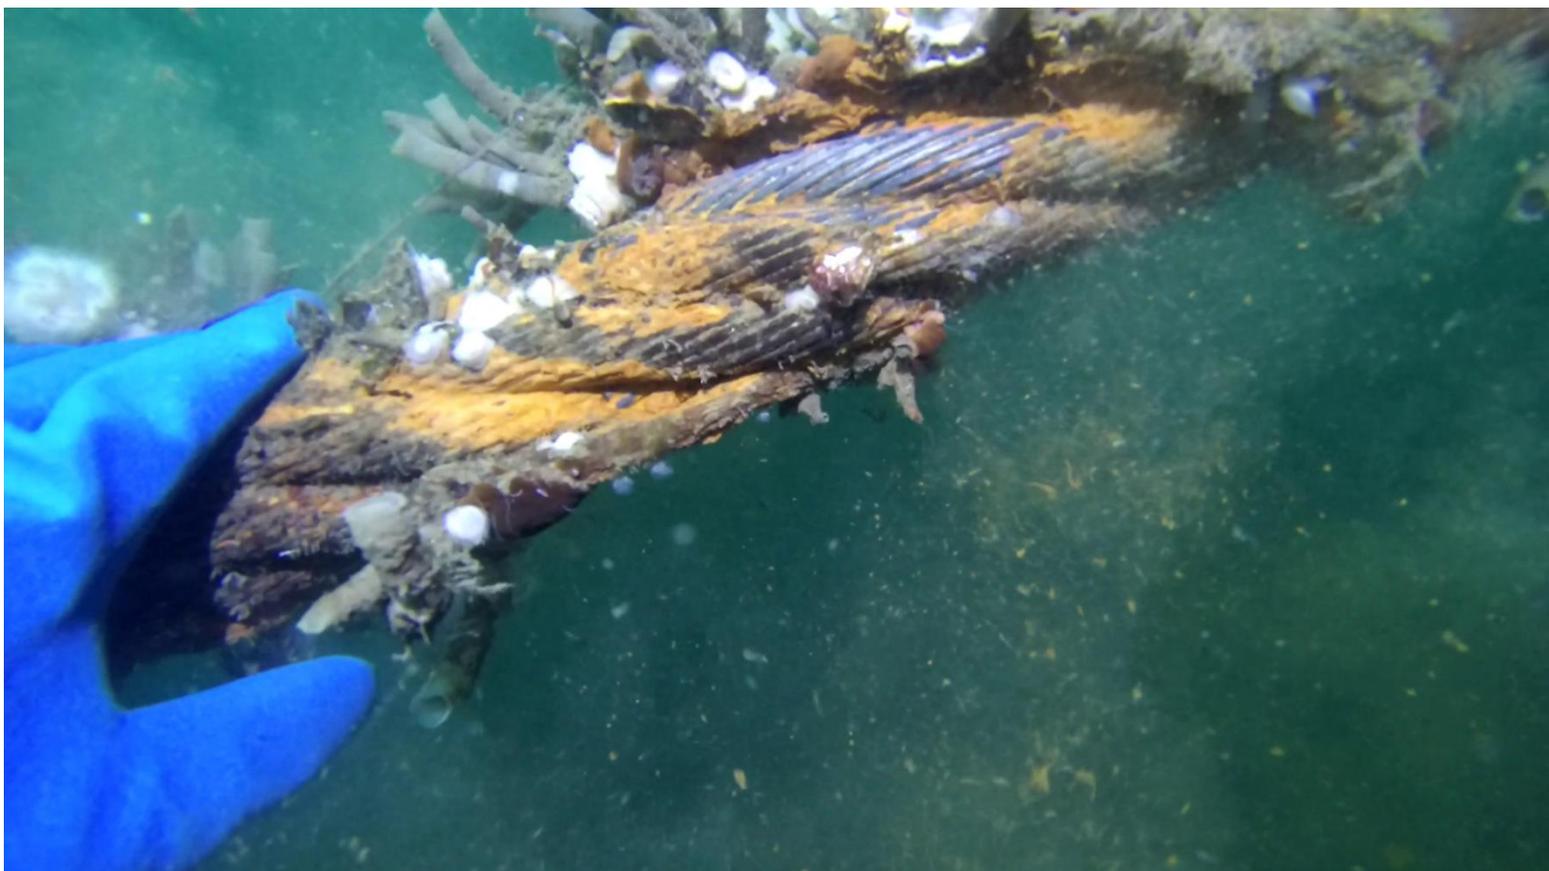
Photo 6: Line 8- Rust & surface deterioration on cable

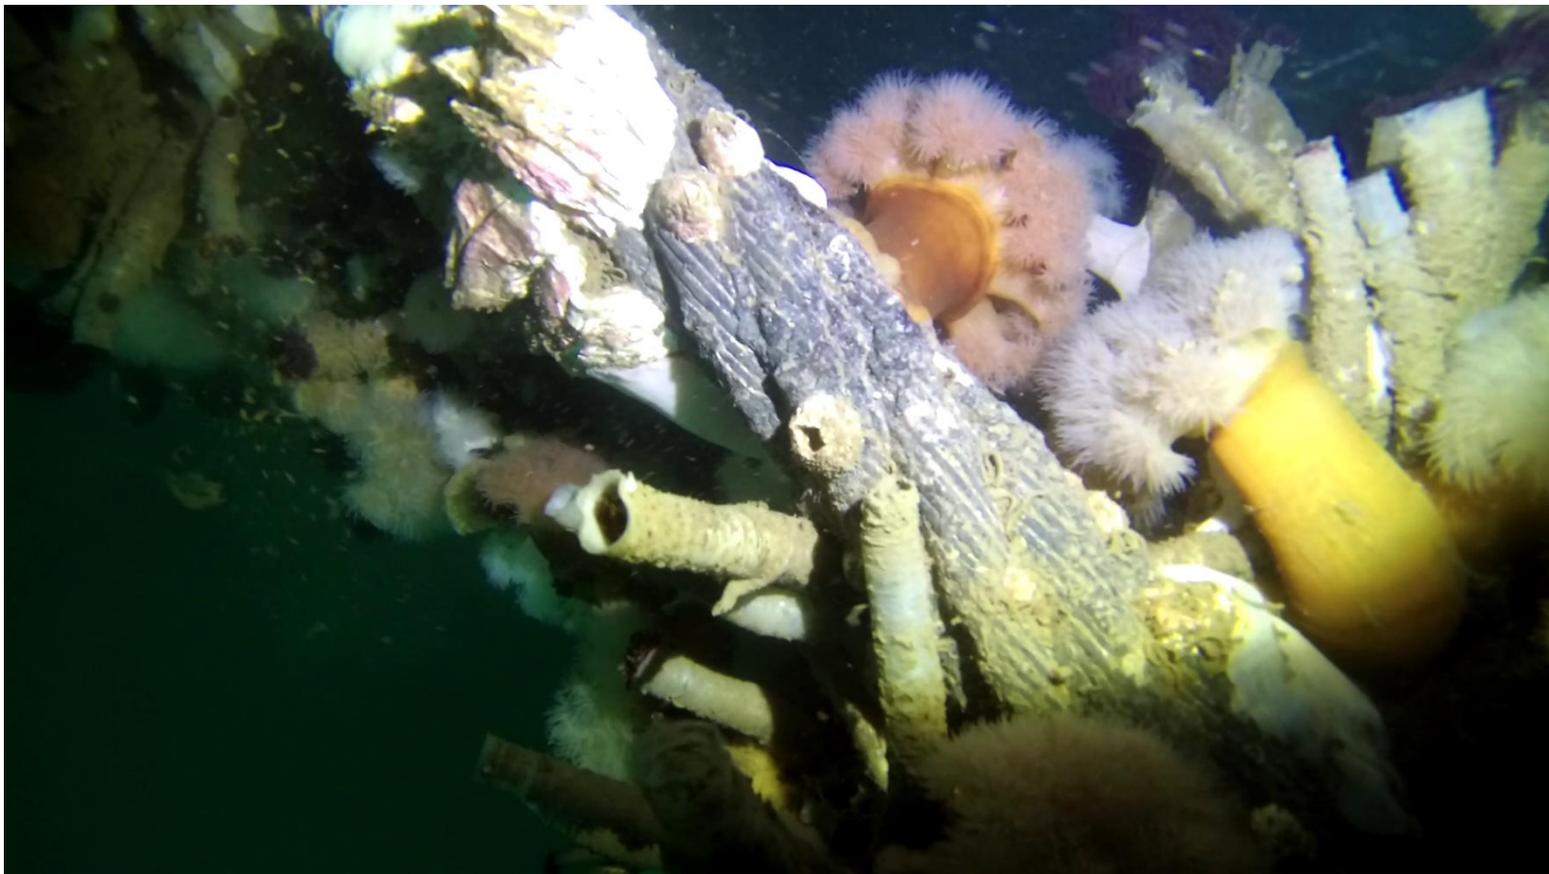
Photo 7: Line 29 - Black corrosion & deterioration on cable

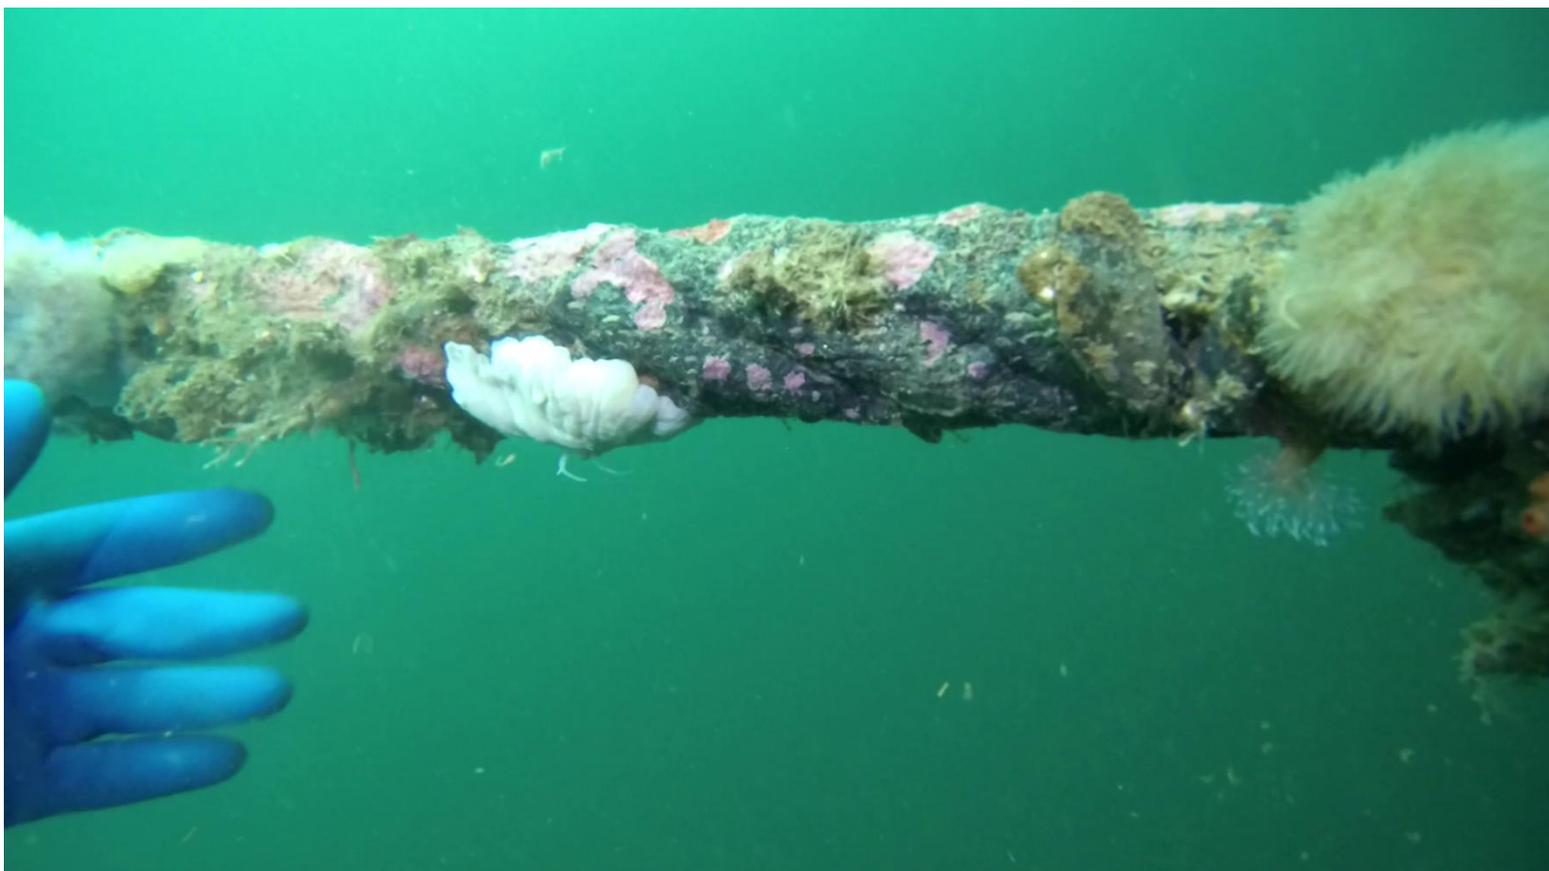
Photo 8: Line 21- Black corrosion layer on cable

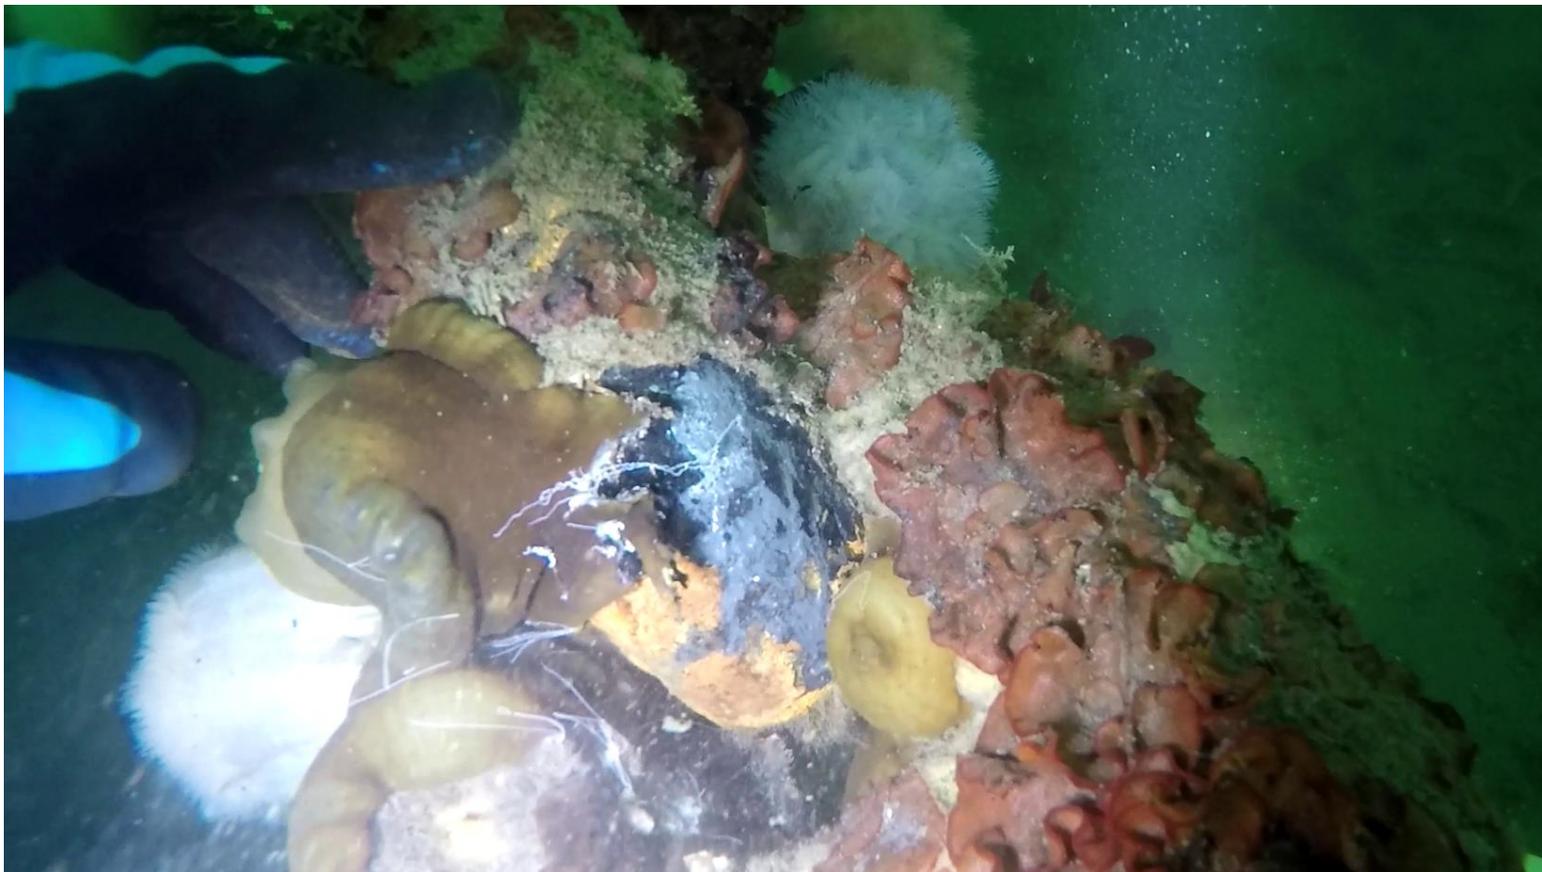
Photo 9: Line 22 - Anchor chain link corrosion cleaned for further inspection

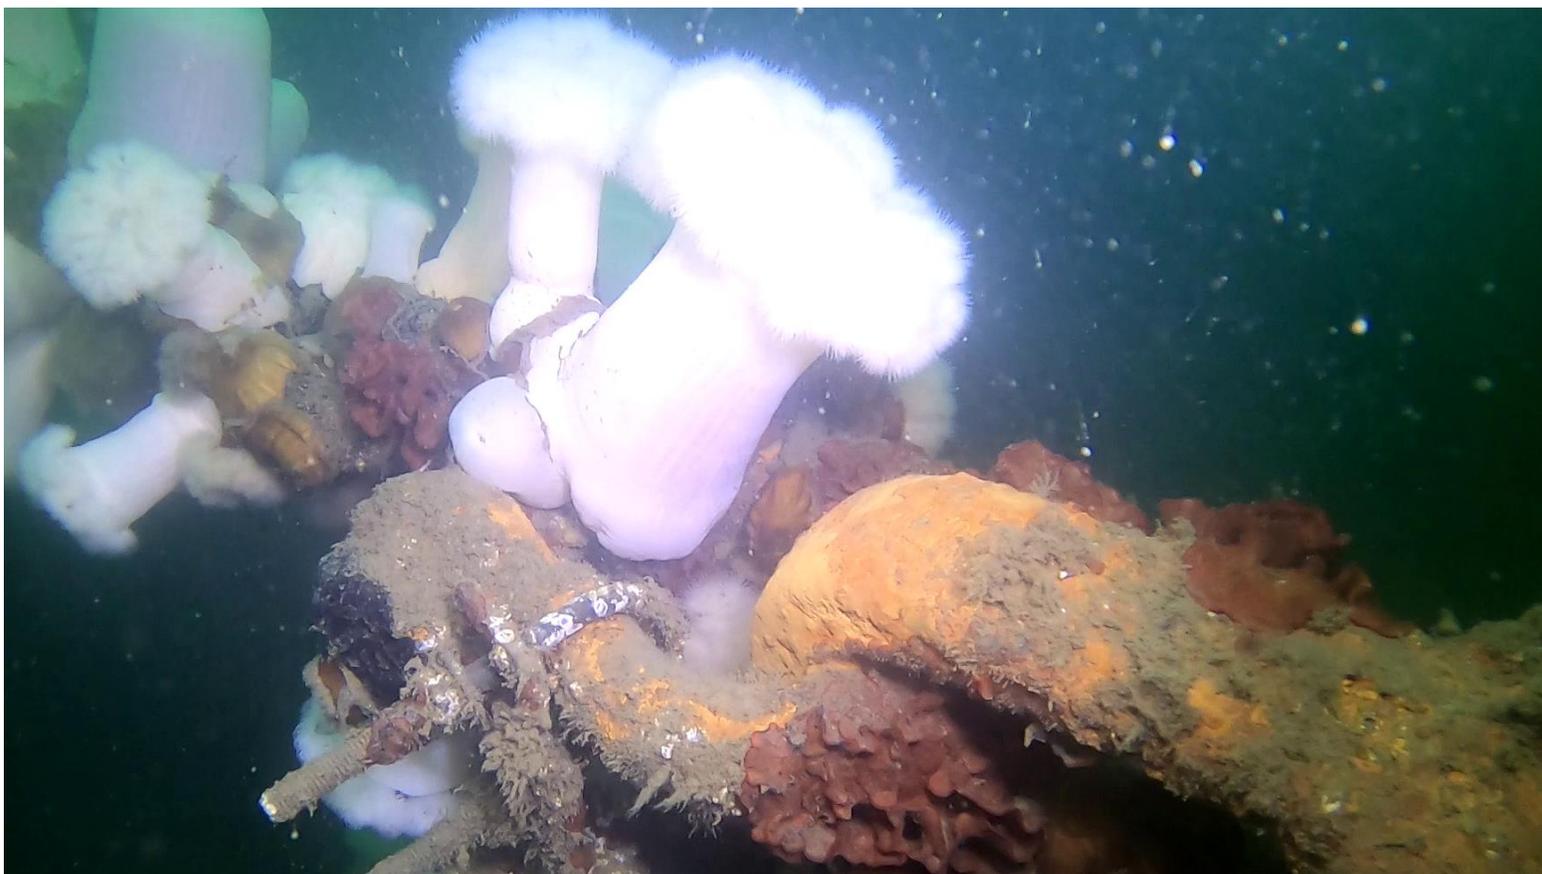
Photo 10: Line 19 – Rust & deterioration on lower eye socket & anchor chain shackle. Typical growth conditions.

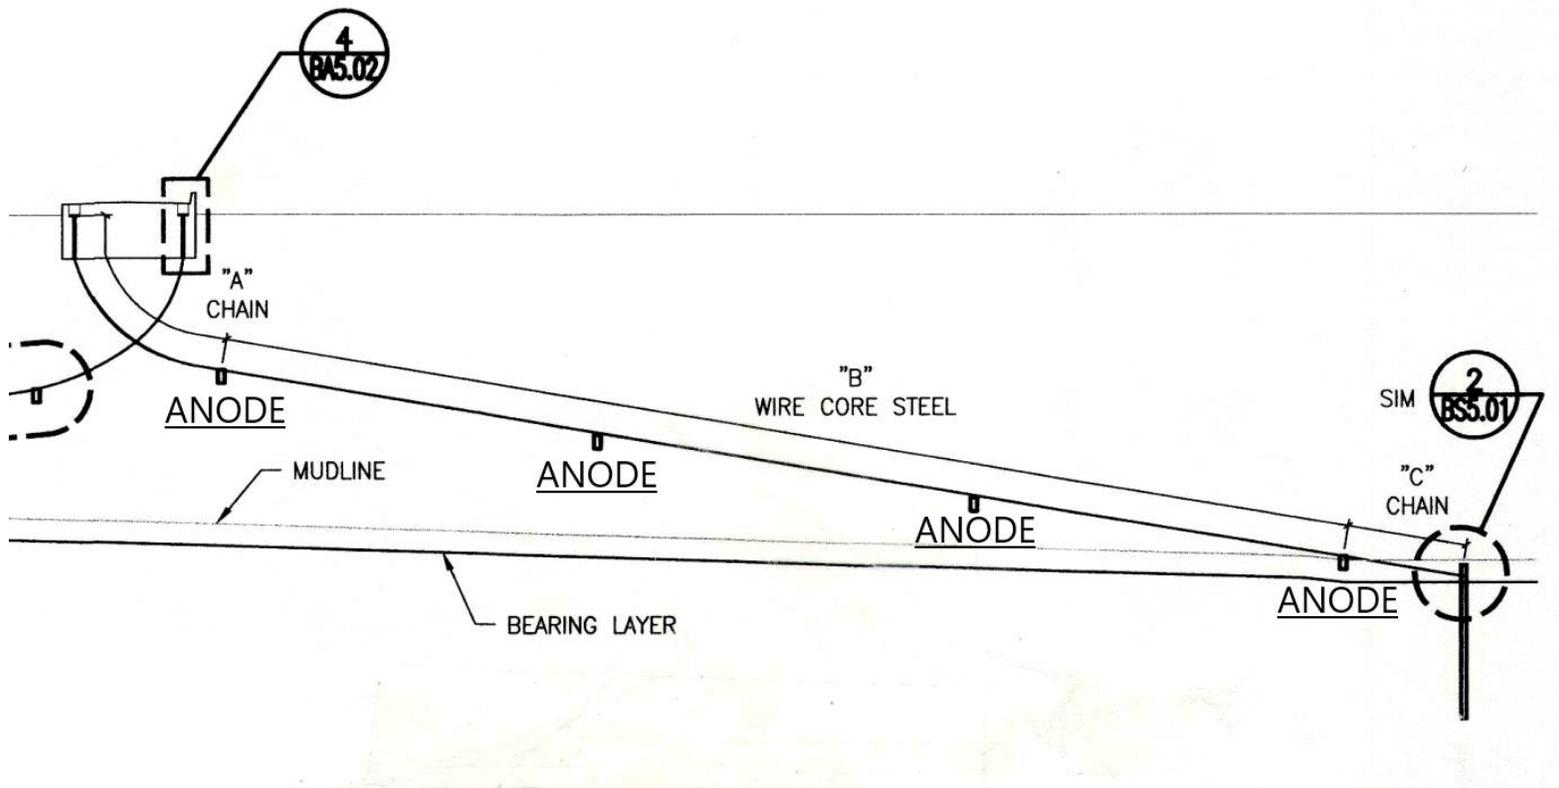
Photo 11: Mooring line anode locations

We gave the anodes a **Poor** grade due a few problems with the anodes: Improper installation, age, and anode location. All mooring lines have 4 locations for anodes. The first location is on the shackle that connects the top chain to the top end of the cable. The next two locations are mounted directly to the cable. The first is 1/3 down the cable and the second is 2/3 down the cable. The fourth anode is located on the shackle that connects lower end of the cable to the bottom chain. (See photo 11)

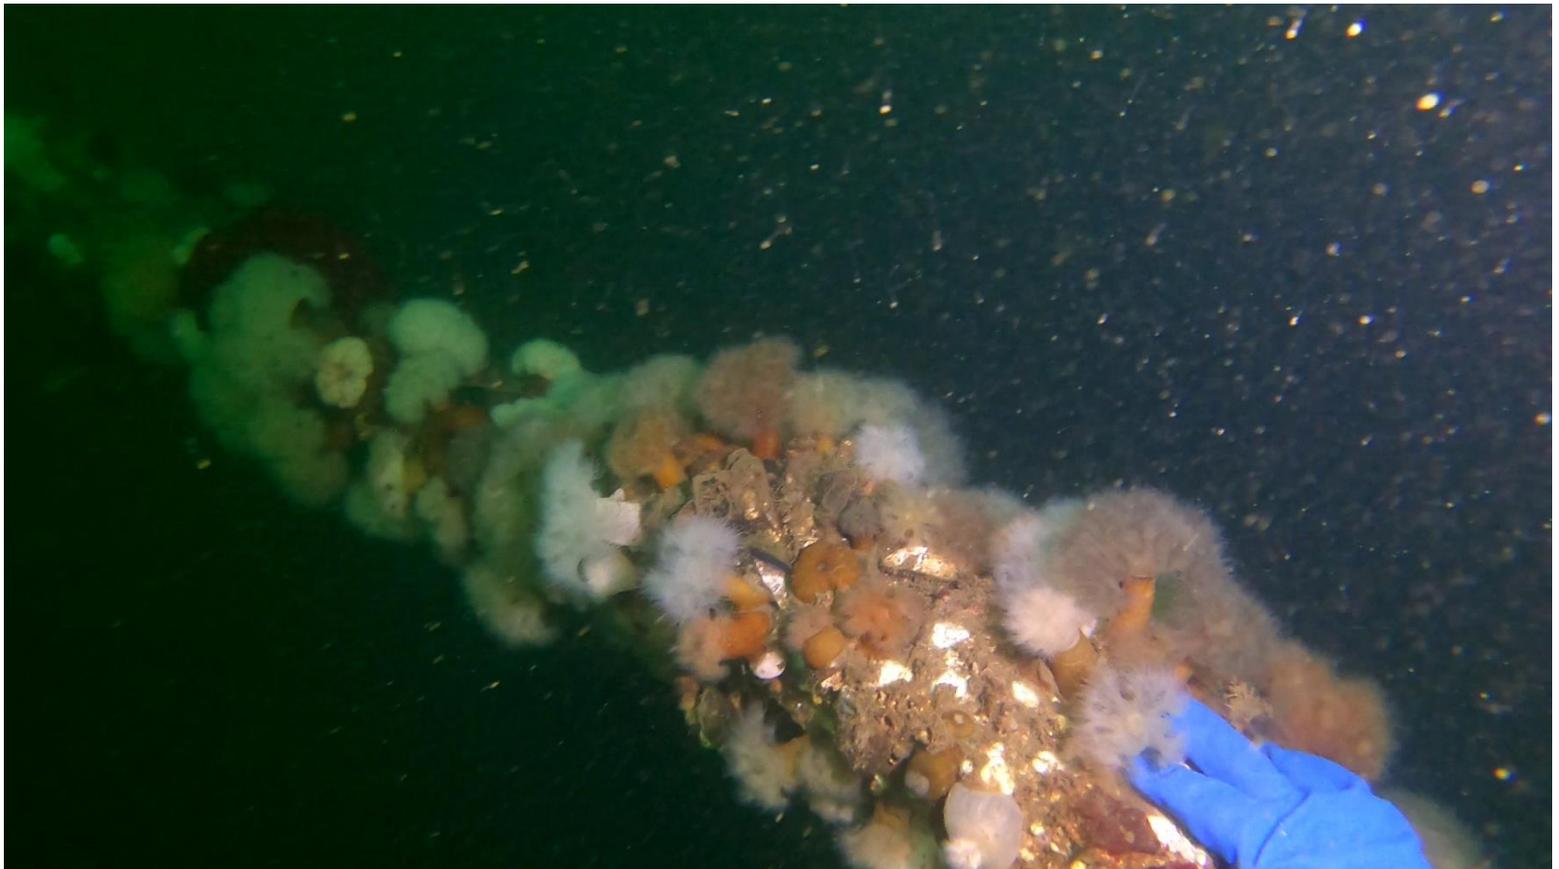
The first anode location is ideal due to the minimal marine growth near the chain to cable connection whereas the rest of the top chain is covered in large tube worm colonies. The horizontal anodes with hardware on both ends seem to be less effective than the vertically hanging anodes. It does appear the dual rod-type anodes would be more difficult to install rather than a single rod anode. Marine growth also spreads much more aggressively over the horizontally mounted anodes providing less surface area for the anodes to do their job. **(See photo 12 -13)**

Photo 12: Line 3 - Horizontal rod anode on cable covered in marine growth

It does appear the dual rod-type anodes with one rod on each end would be more difficult to install. SDS also noted these horizontally mounted anodes to be covered in more marine growth with little to no surface area exposed. This in turn provides less cathodic protection and could make it harder to find these anodes during inspections. If rod type anodes are used, a single rod option appears to be the best choice as they were effective for the Port Orchard Marina breakwater.

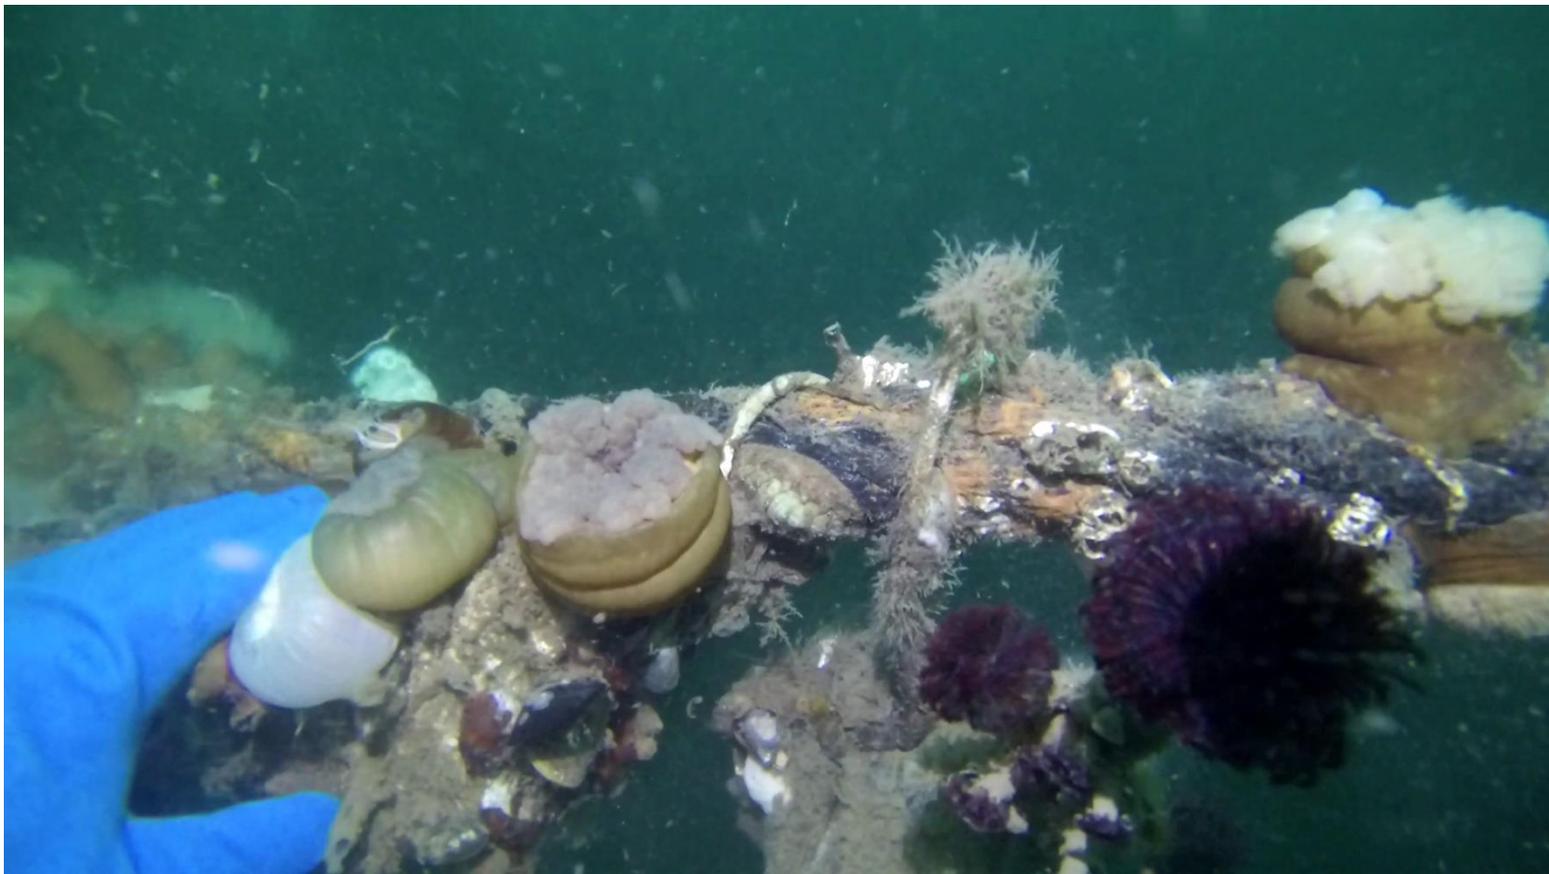
These anodes seem to be a more diver friendly installation option than the u bolt anodes with multiple pieces of hardware. We recommend a single rod type anode that can hang vertically, this style of anode seemed to be effective for the Port Orchard Breakwater mooring chains. Proper pre-cleaning would allow for a tighter wrap and more secure connection. (See photos 13 & 21)

Photo 13: Line 8 - Rod anode on cable with loose connection, & severe corrosion

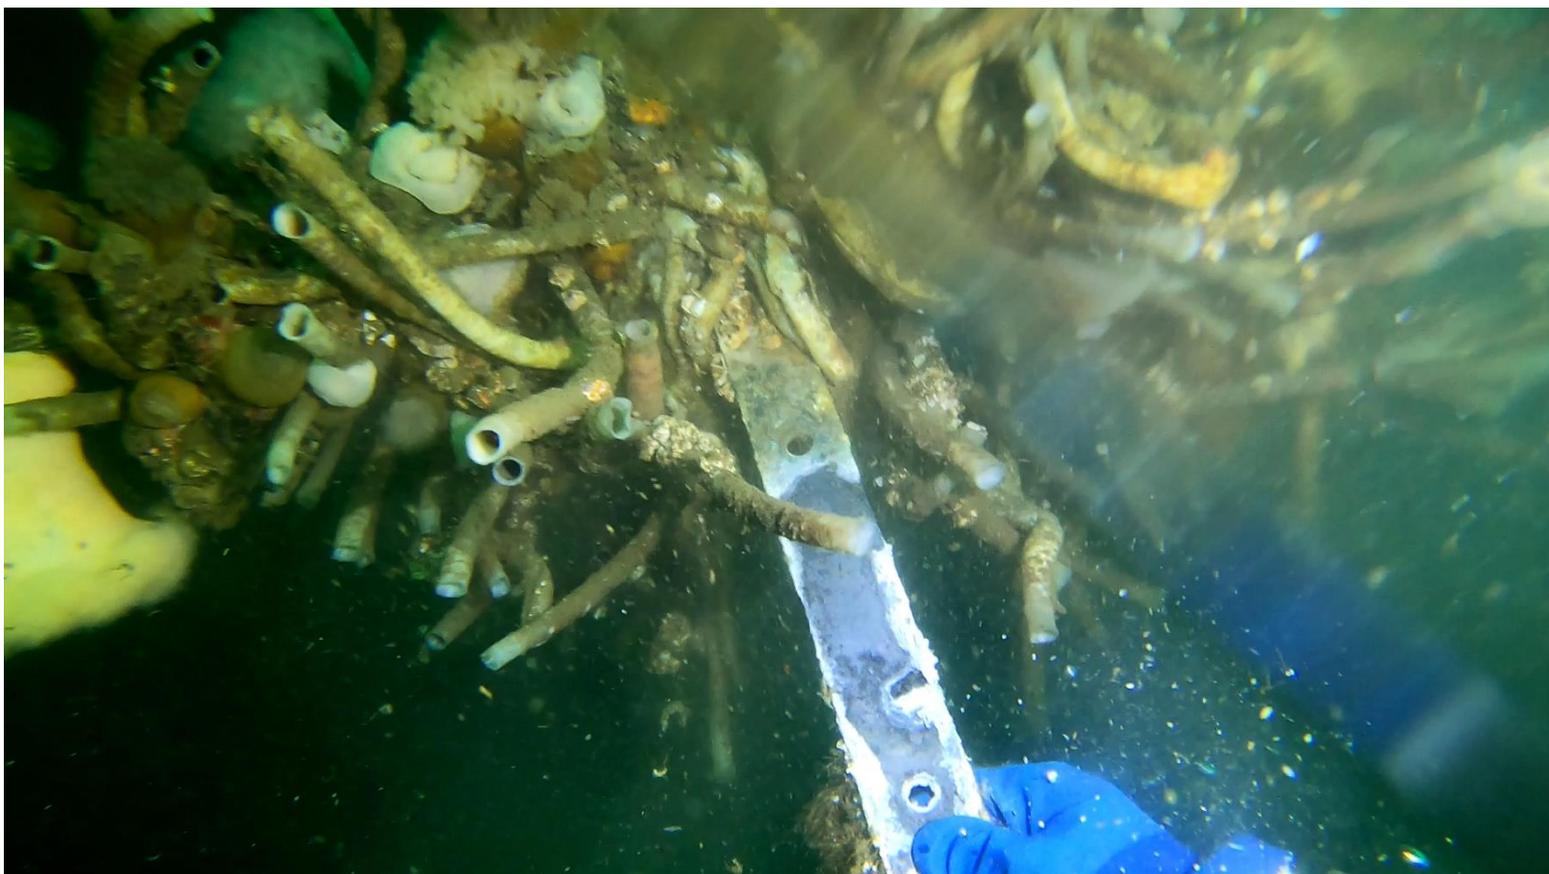
The anodes also were installed over existing marine growth. Or, due to the loose nature of the hardware, allowed marine growth to form between the cable and anode hardware, making a metal to metal bond impossible. A handful of the cable anodes were rod-type anodes with a rod extending from both ends of the anode & both rods wrapped around the cable. We also noticed these were either installed over existing marine growth or the rods we not wrapped tightly enough so marine growth was allowed to grow on the cable, between the rods preventing to a metal to metal bond. When looking at the anode percentage chart, newer anodes with a high percentage of material remaining have **poor** or no metal-metal connection. **(See photos 14-19)**

Photo 14: Line 5 - Old hardware attached securely to mooring line
