**INVITATION FOR PROPOSAL #03-24-30028
Bremerton Marina Underwater Inspections**

Addendum 1, 11/13/2024

BREMERTON MARINA BREAKWATER

USS TURNER JOY - MOORING SYSTEM

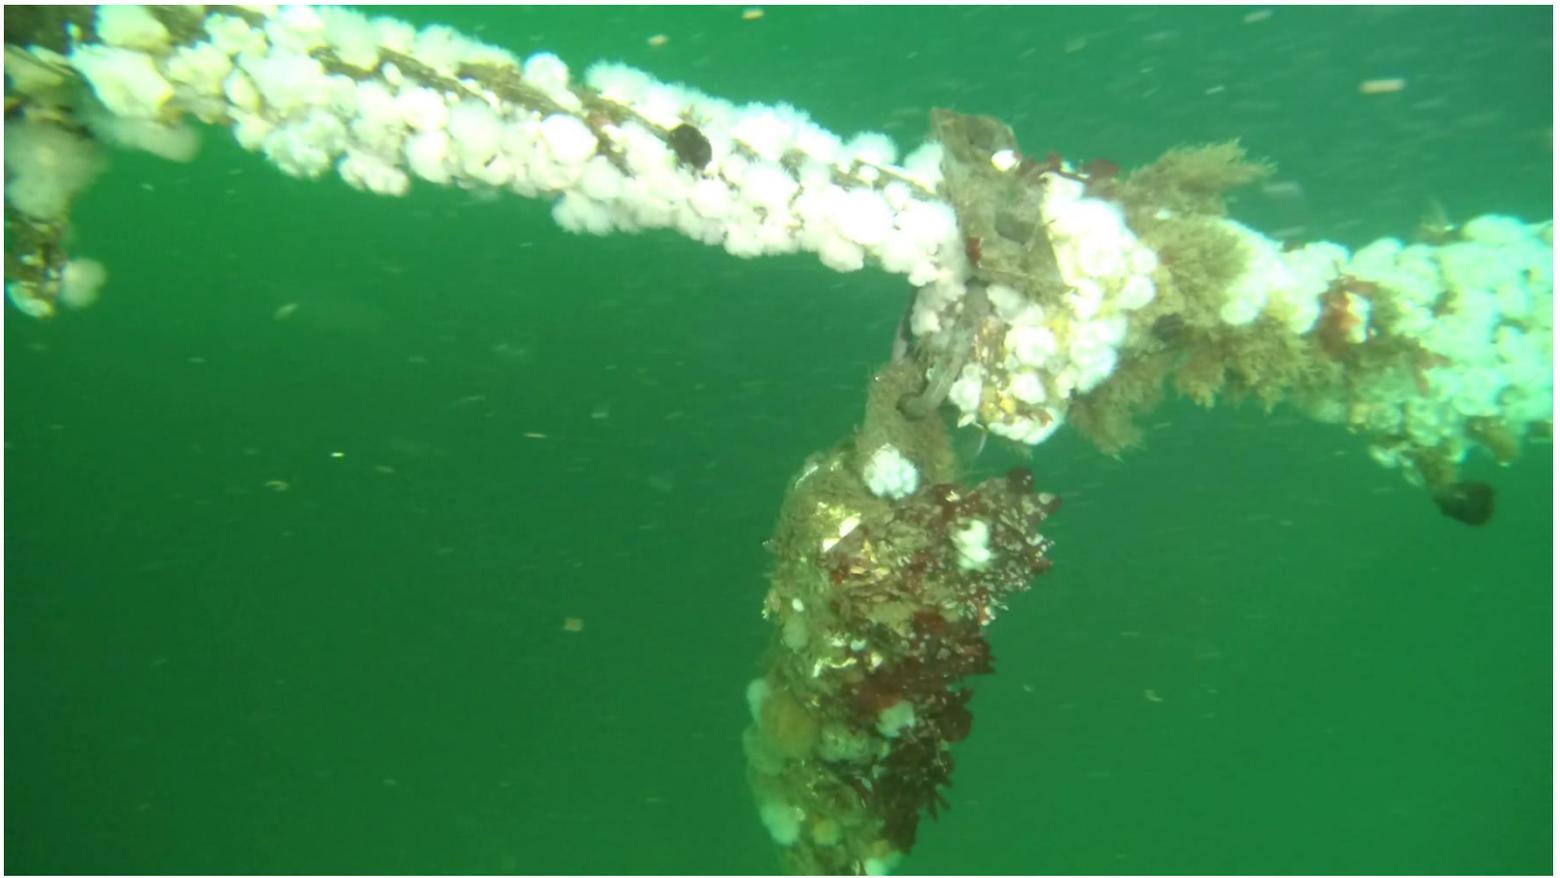
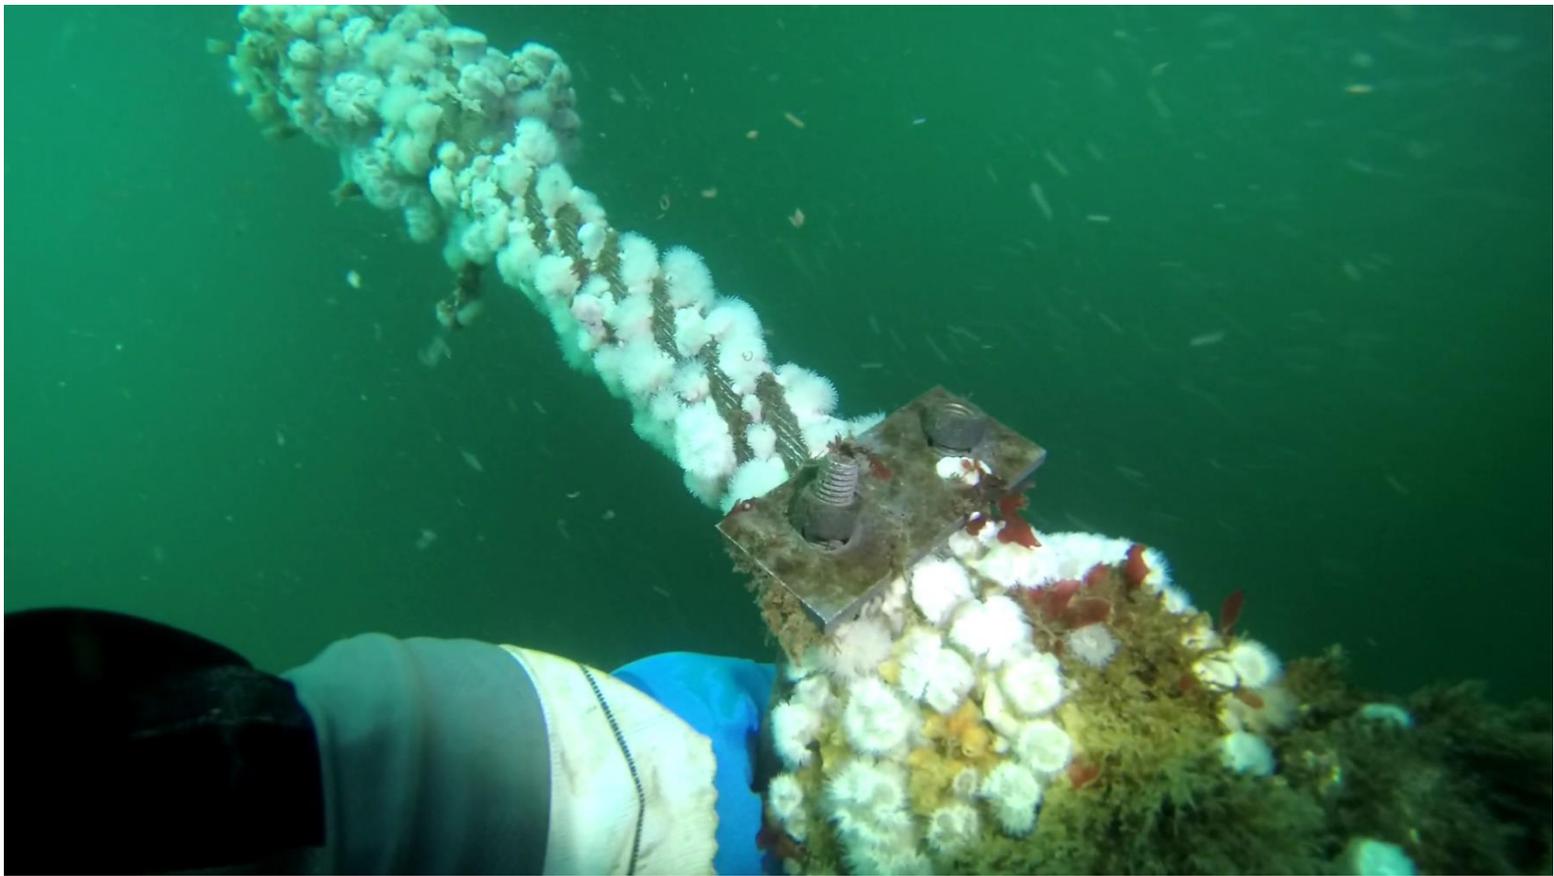
The anodes also were installed over existing marine growth. Or, due to the loose nature of the hardware, allowed marine growth to form between the cable and anode hardware, making a metal to metal bond impossible. A handful of the cable anodes were rod-type anodes with a rod extending from both ends of the anode & both rods wrapped around the cable. We also noticed these were either installed over existing marine growth or the rods we not wrapped tightly enough so marine growth was allowed to grow on the cable, between the rods preventing to a metal to metal bond. When looking at the anode percentage chart, newer anodes with a high percentage of material remaining have **poor** or no metal-metal connection. **(See photos 14-19)**

Photo 15: Line 44 - Typical newer anode with loose hardware, nuts backing off

Photo 19: Line 44 - Typical newer anode with loose hardware, nuts backing off

The Port/ Port Engineer should consider including anodes with poor connections, loose hardware, failed hardware and marine growth on the mooring lines in a repair contract as soon as practical. The single hex nuts were finger loose and some hex nuts were missing. At a minimum these should be tightened to prevent losing more anodes. In addition, consider a section of bendable rod that can provide a better connection between the existing u-bolt hardware and the mooring lines. This would help salvage the remaining service life of these anodes, it is assumed they are providing little to no cathodic protection for the mooring system.

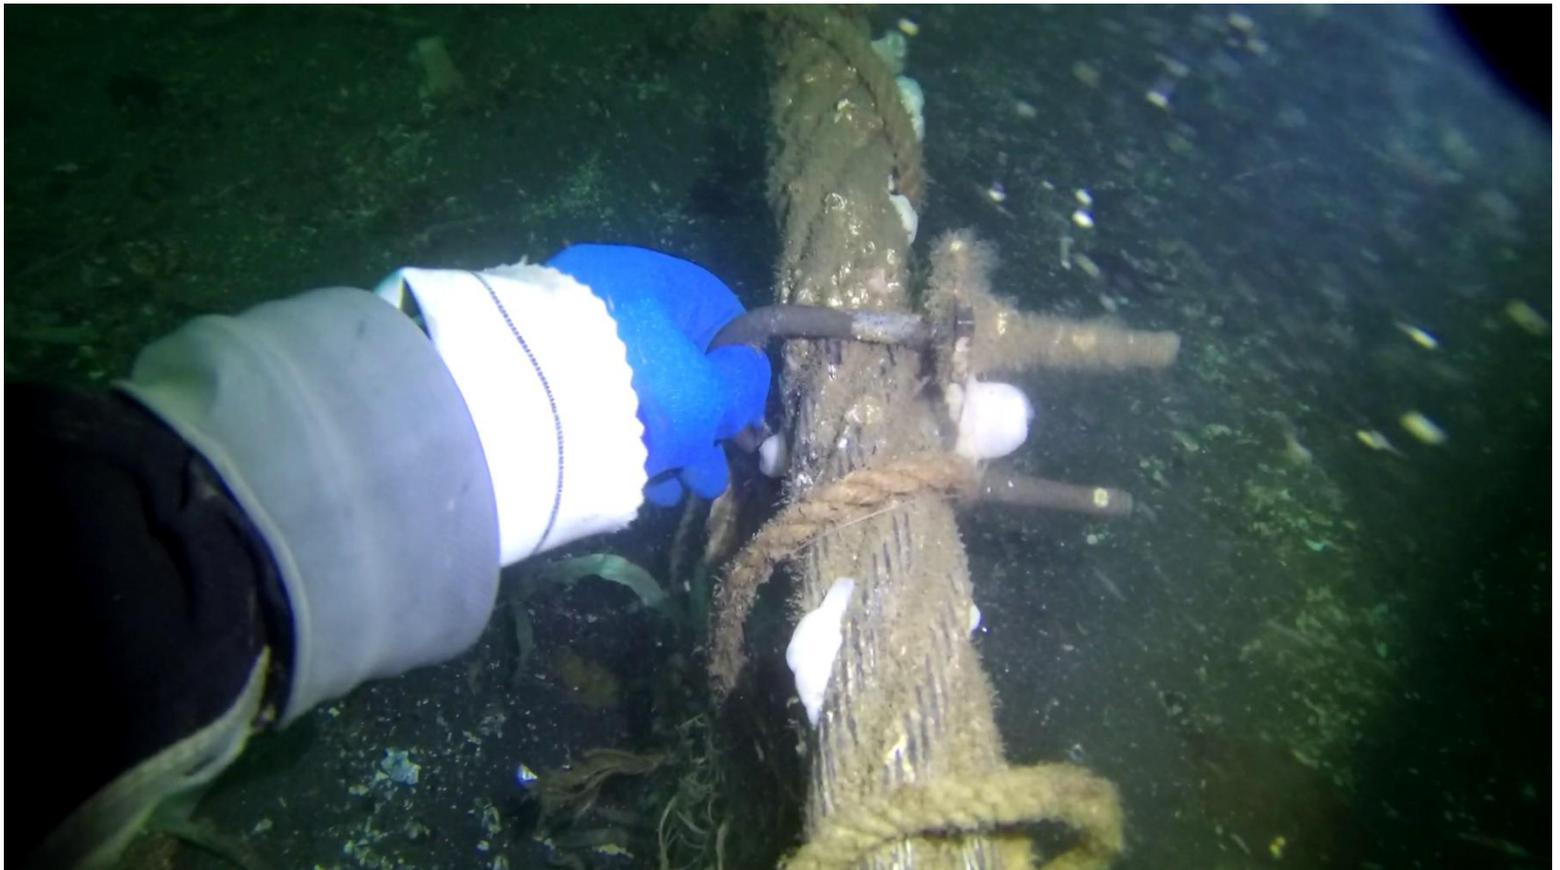
Photo 16: Line 30 - Typical newer anode with loose hardware, nuts fully tightened

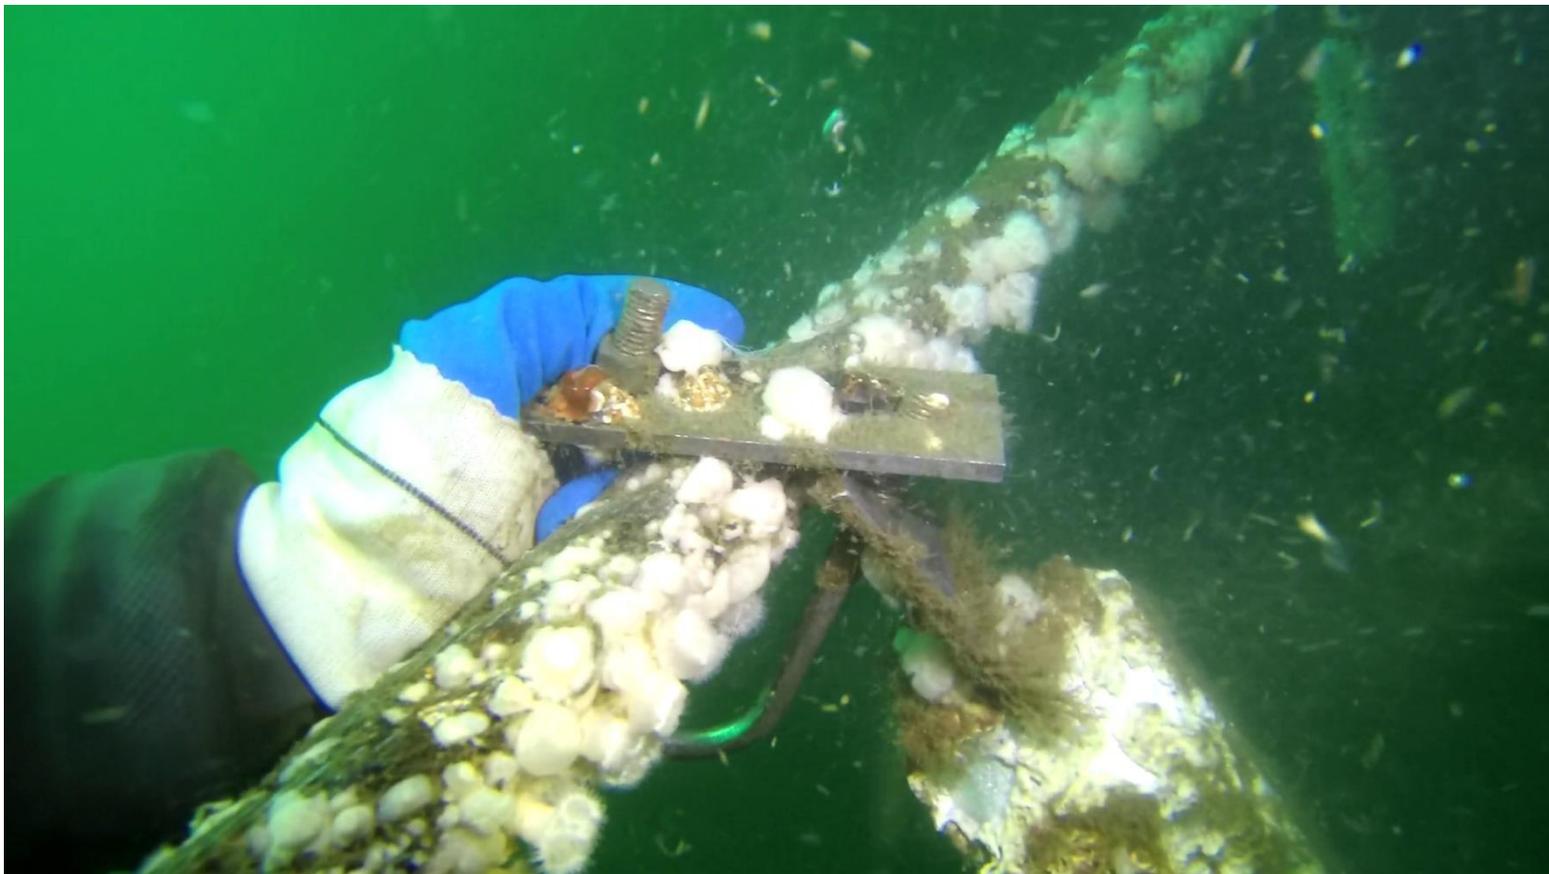
Photo 17: Line 23 - Typical newer anode with hex nut missing

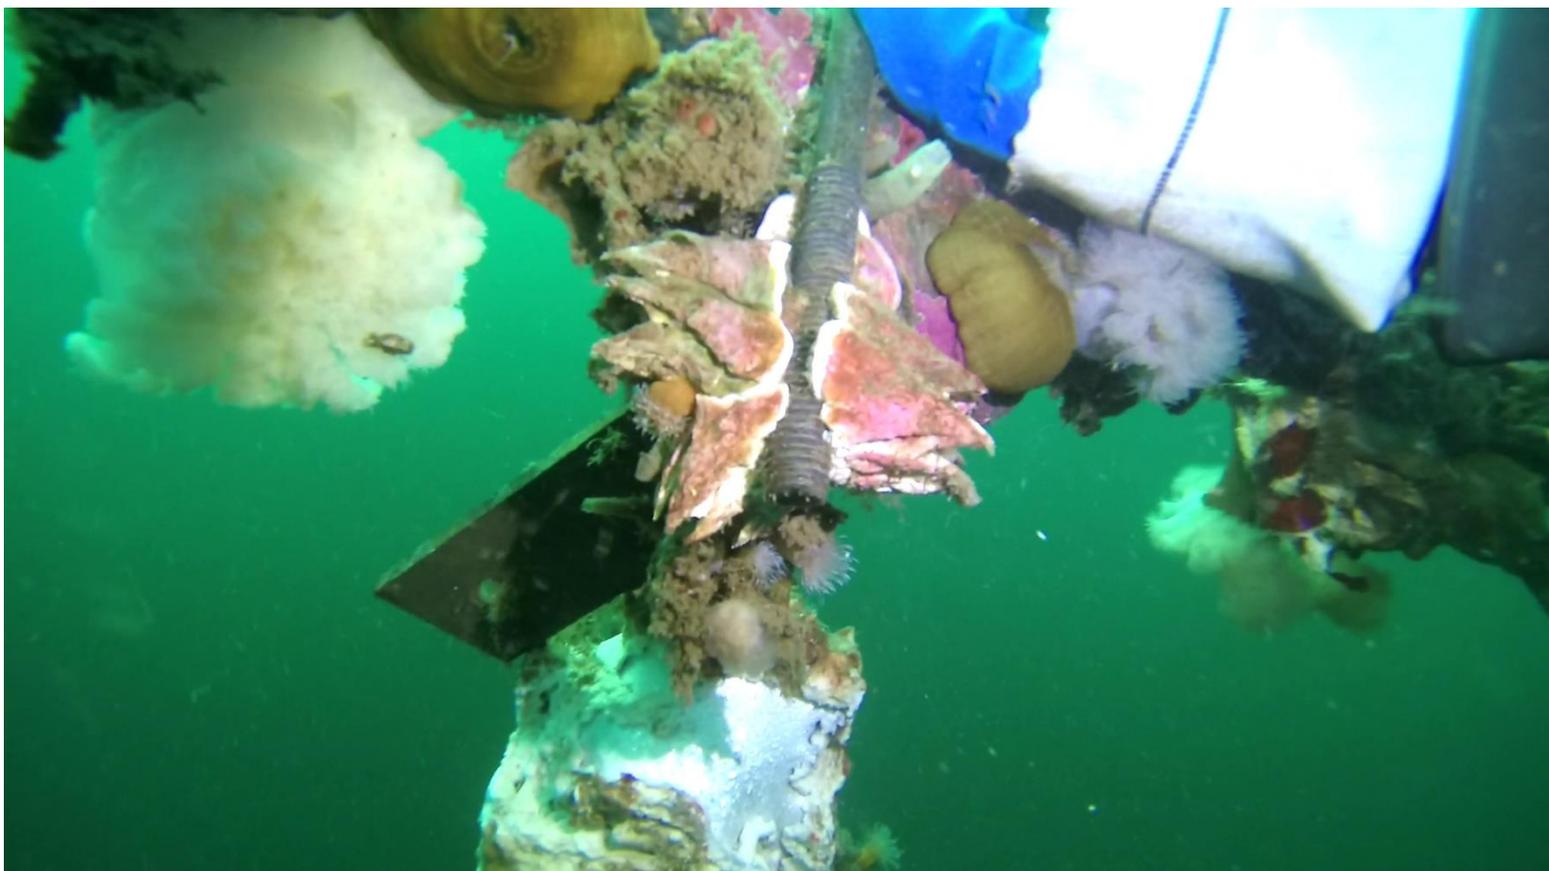
Photo 18: Line 20N - Typical newer anode with hex nut missing

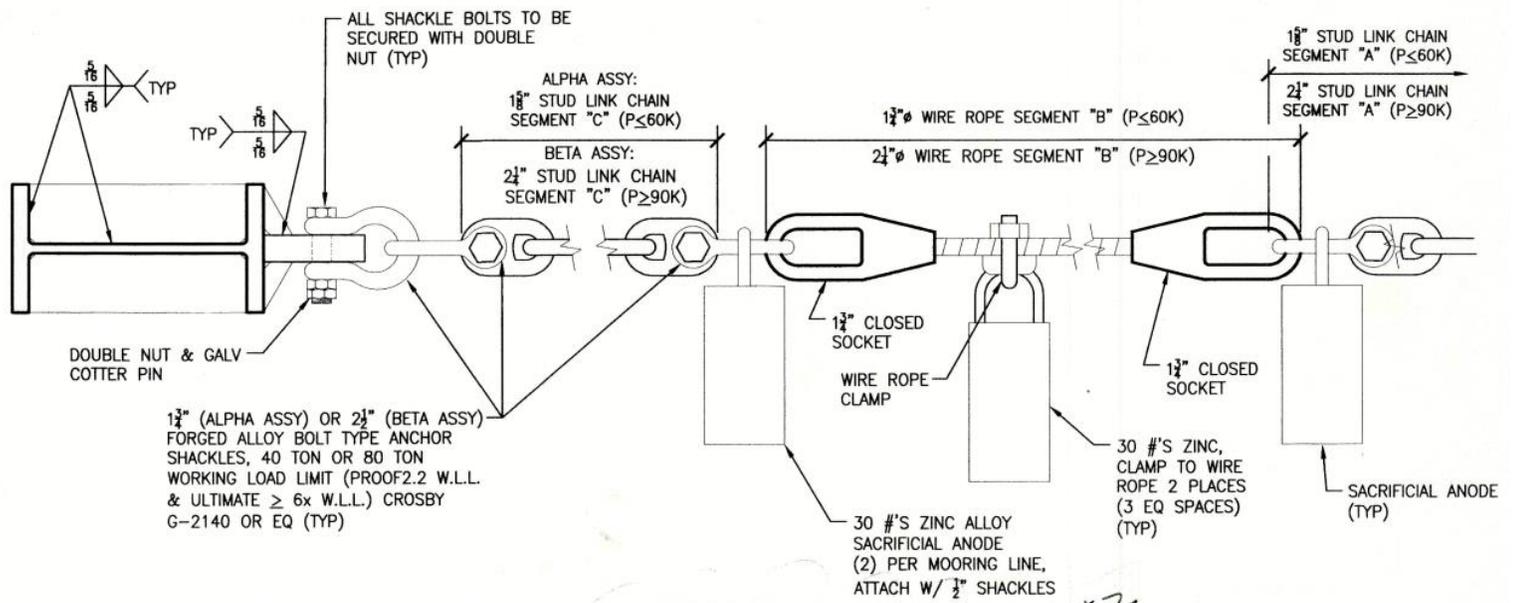
Photo 20: Original anode specs & locations

The majority of the bottom chain anodes are fully depleted or have less than one year of service life left. Those bottom chains are forming a layer of corrosion that when chipped away, reveals up to 20% material loss, weakening the overall integrity of the mooring line. It is high importance to ensure when the new anodes are installed, marine growth and this corrosion layer is removed, and a secure connection must be made. Otherwise, the bottom chains will deteriorate and need replacement within 10 years. By looking at the original plans for the mooring systems and the old anode hardware on the mooring chains, it appears that **two** anodes were originally installed at the connection point. This should be considered when planning future maintenance. **(See photo 20)**

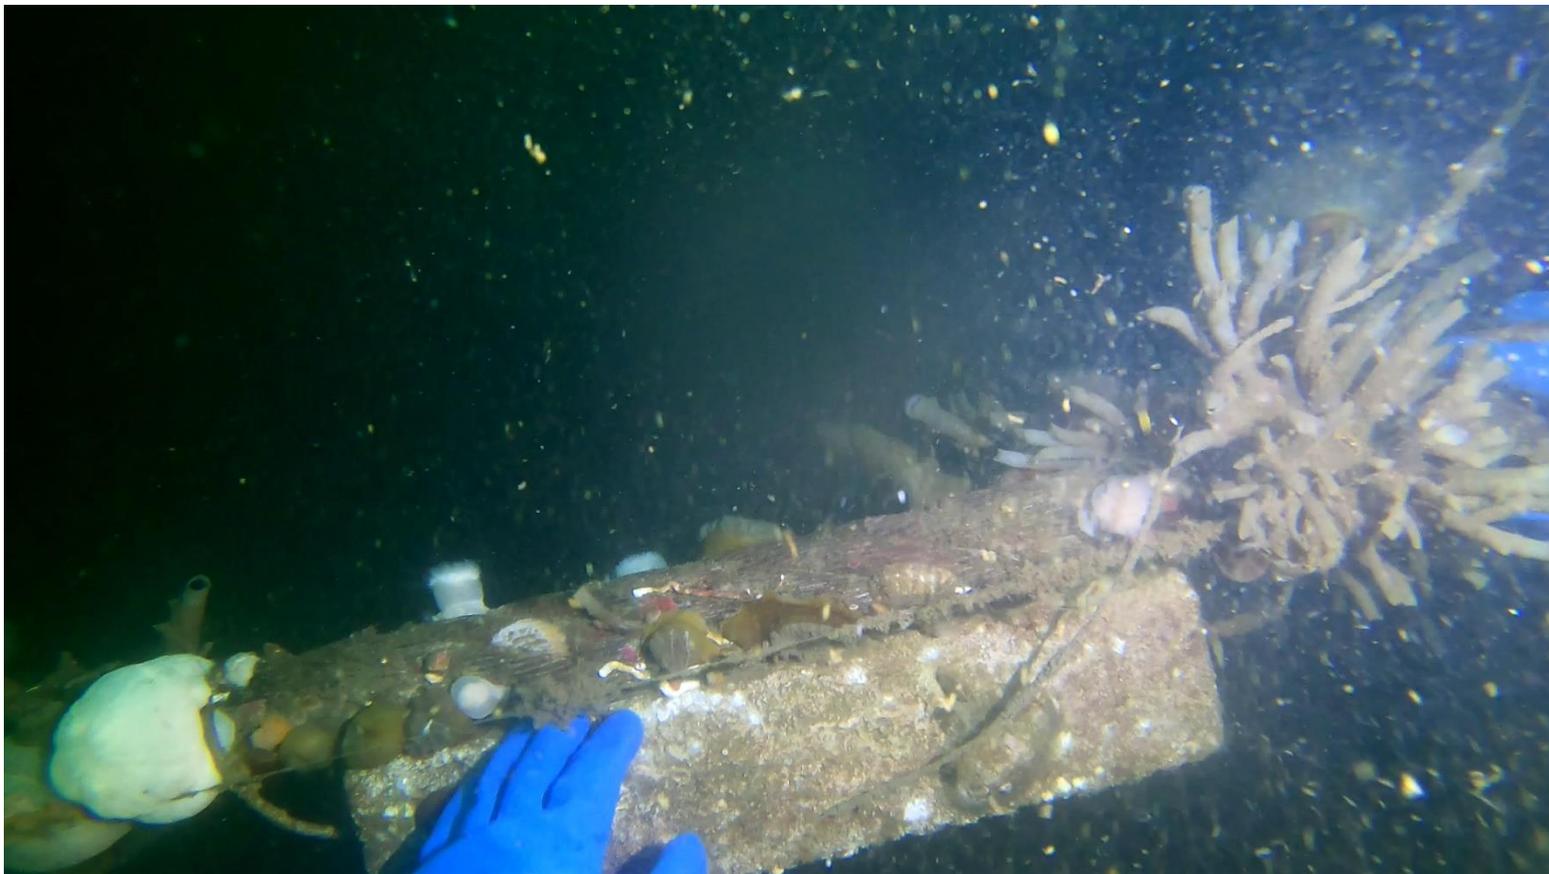
These anodes seem to be a more diver friendly installation option than the u bolt anodes with multiple pieces of hardware. We recommend a single rod type anode that can hang vertically, this style of anode seemed to be effective for the Port Orchard Breakwater mooring chains. Proper pre-cleaning would allow for a tighter wrap and more secure connection. (See photos 13 & 21)

Photo 21: Line 2 - Typical dual rod anode condition

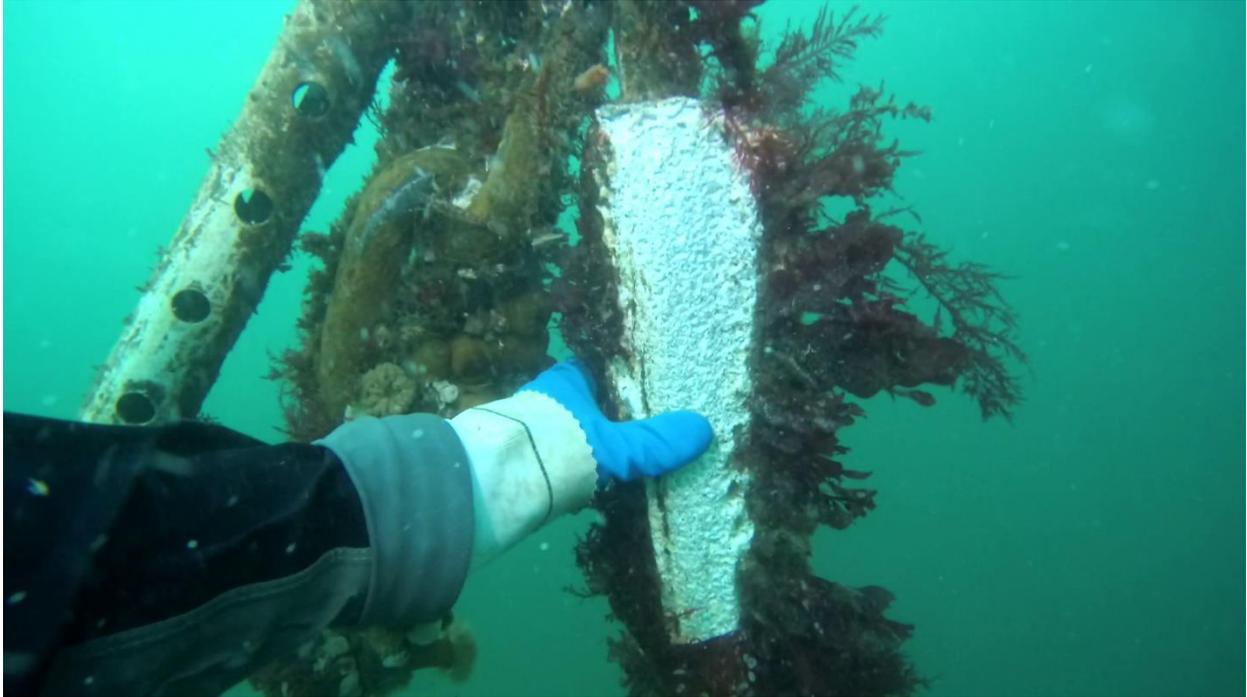
The mooring systems are in overall in **Fair** condition overall with limited areas of advanced deterioration & corrosion. The buoy chains are generally free of marine growth while the bow and anchor chains below the surface have about 75% surface coverage of moderate marine growth. The anodes were generally free of marine growth but this varied from 0% - 50% surface coverage. In general, all four mooring lines and associated hardware are in identical condition. (See photos 22-25)

Photo 22: Typical bow chain anode condition

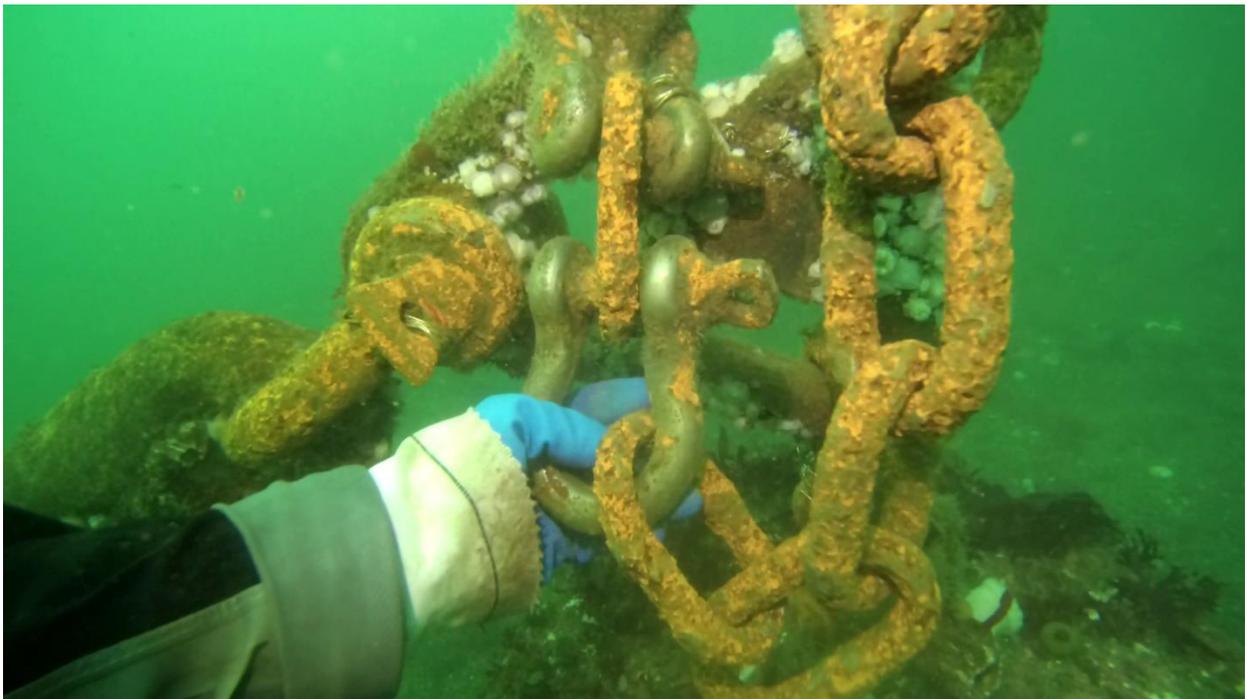
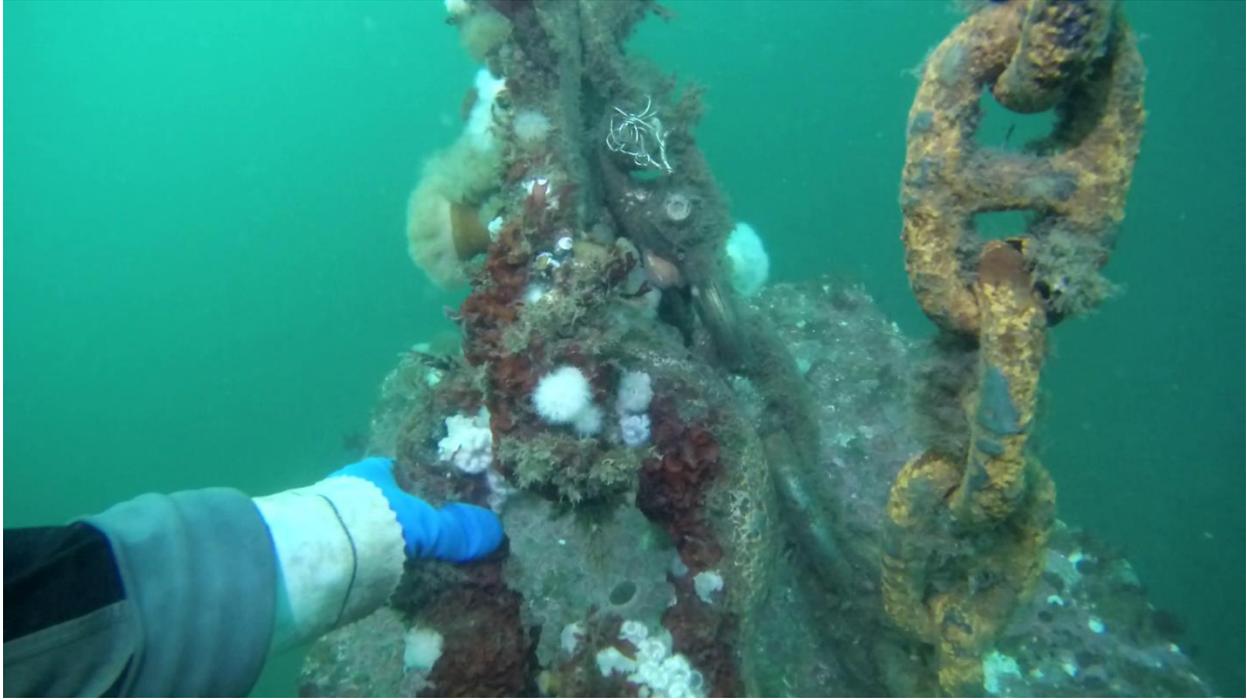
Photo 23: Typical buoy chain, flounder plate, & hardware conditions

Photo 24: Typical buoy chain, flounder plate, & hardware conditions

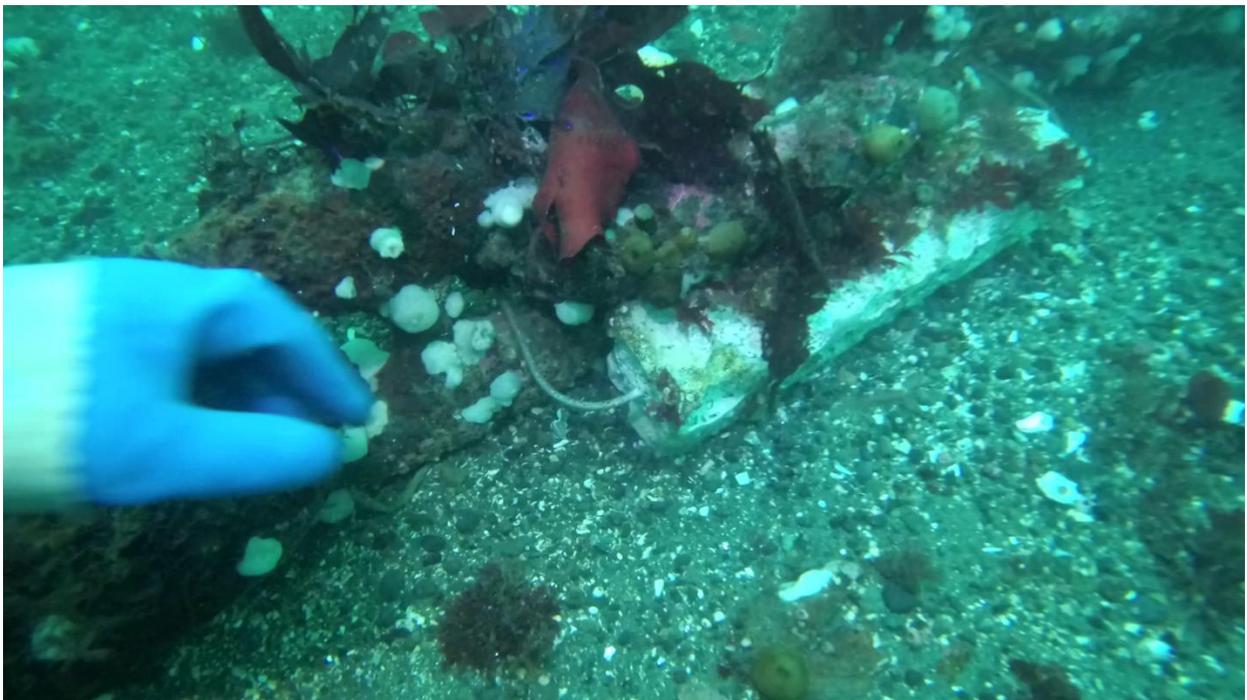
Photo 25: Typical anchor chain and anode condition

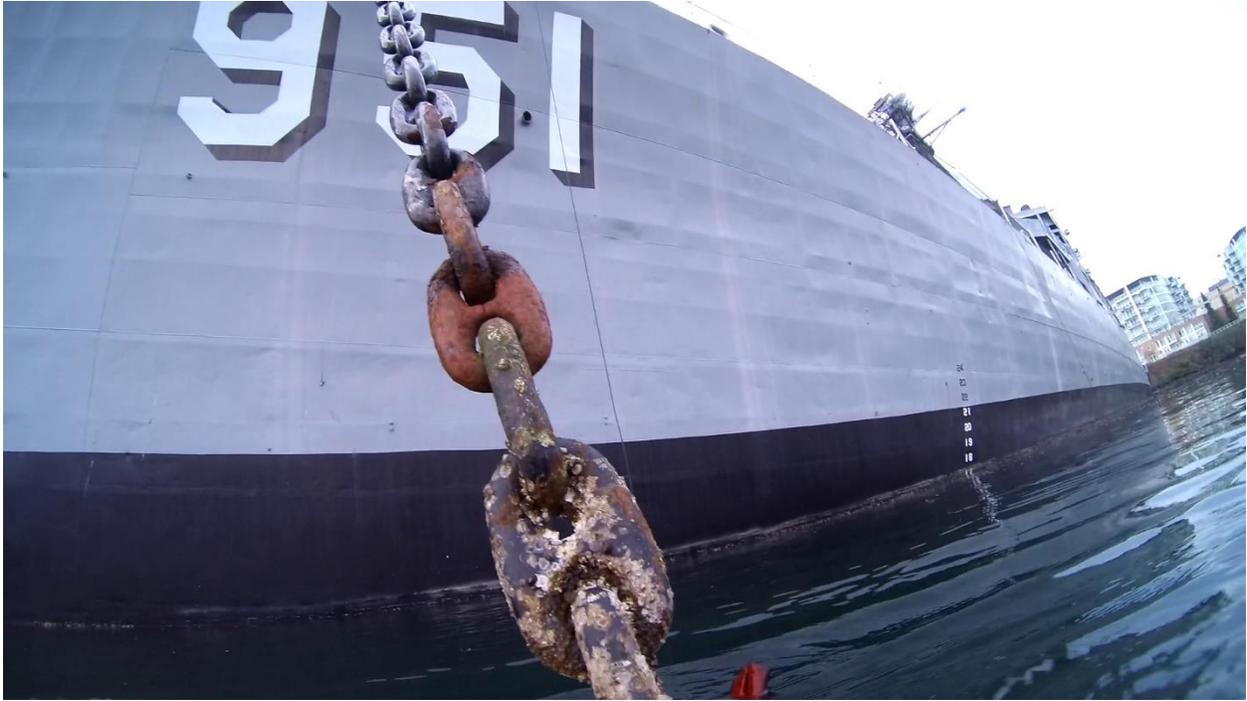
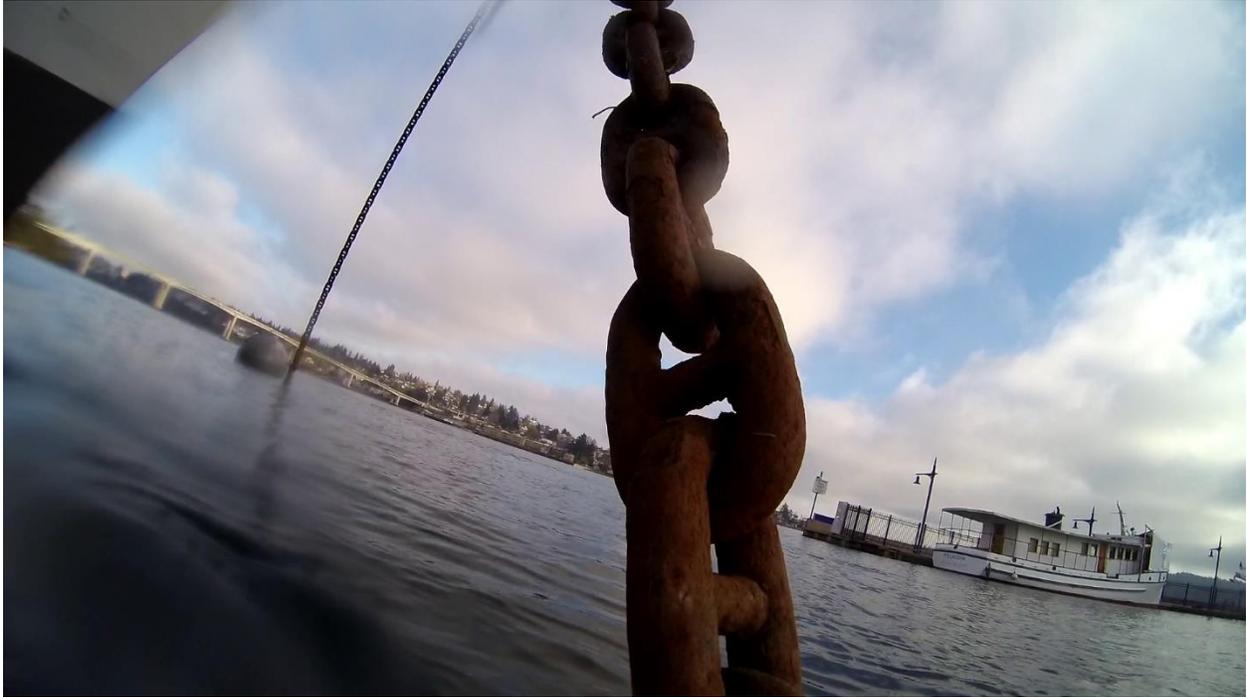
Surface corrosion on the bow chains seems to have subsided since the last inspection. With the exception of the splash zone, the wax coating applied to the bow chains seems to be limiting corrosion and marine growth. The wax coating on the splash zones likely washed away over time from weathering, etc. Each of the bow chains have one anode installed. The bow chain anodes are installed with oversized u-bolt hardware. There is not a tight, secure connection but there is little to no corrosion below the surface on the bow chains. (See photos 26-27)

Photo 26: Typical bow chain splash zone condition

Photo 27: Typical bow chain splash zone condition

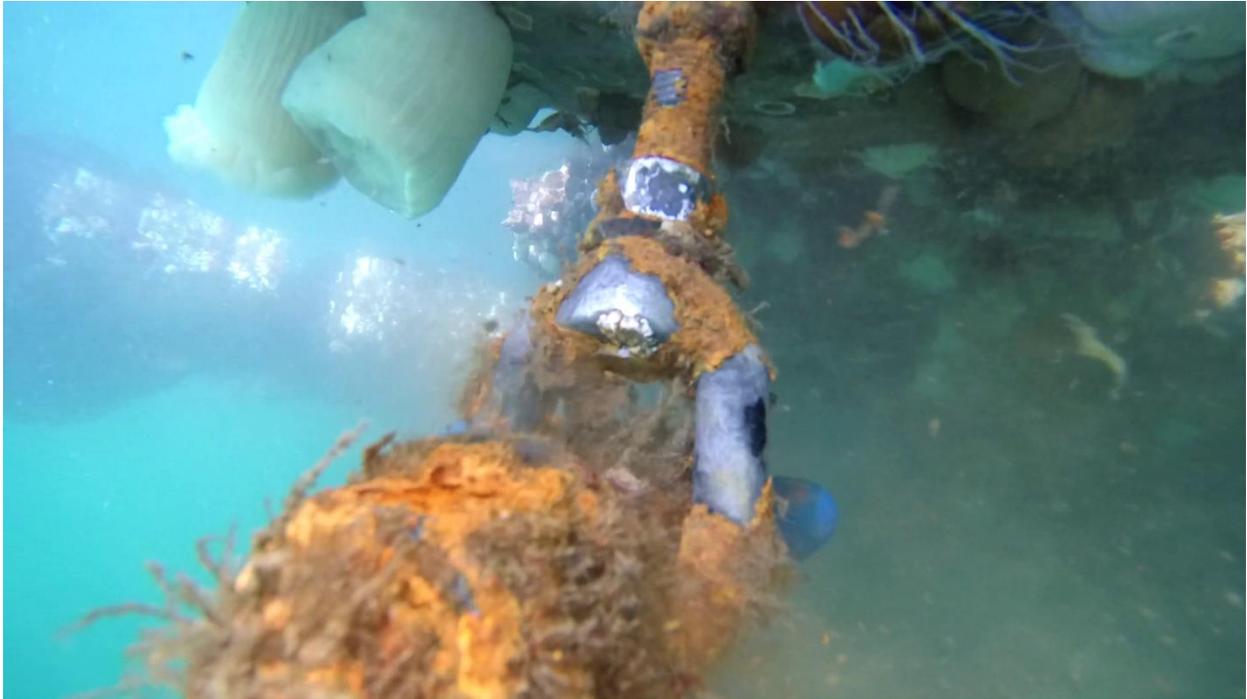
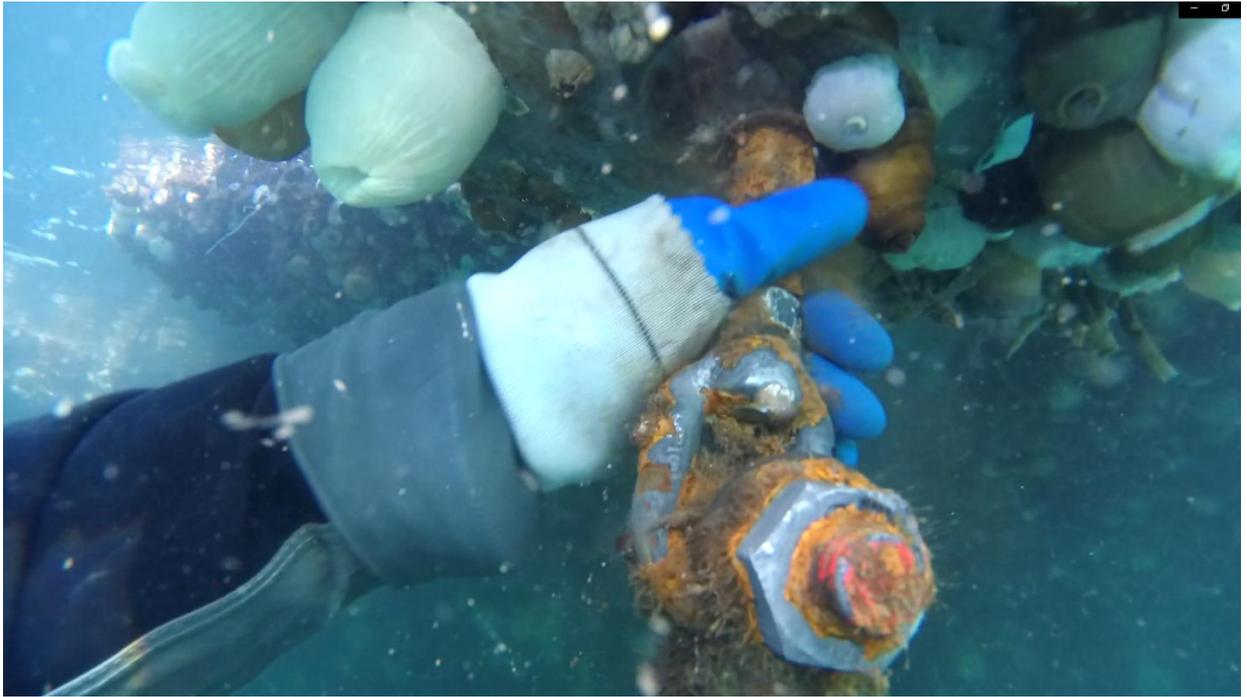
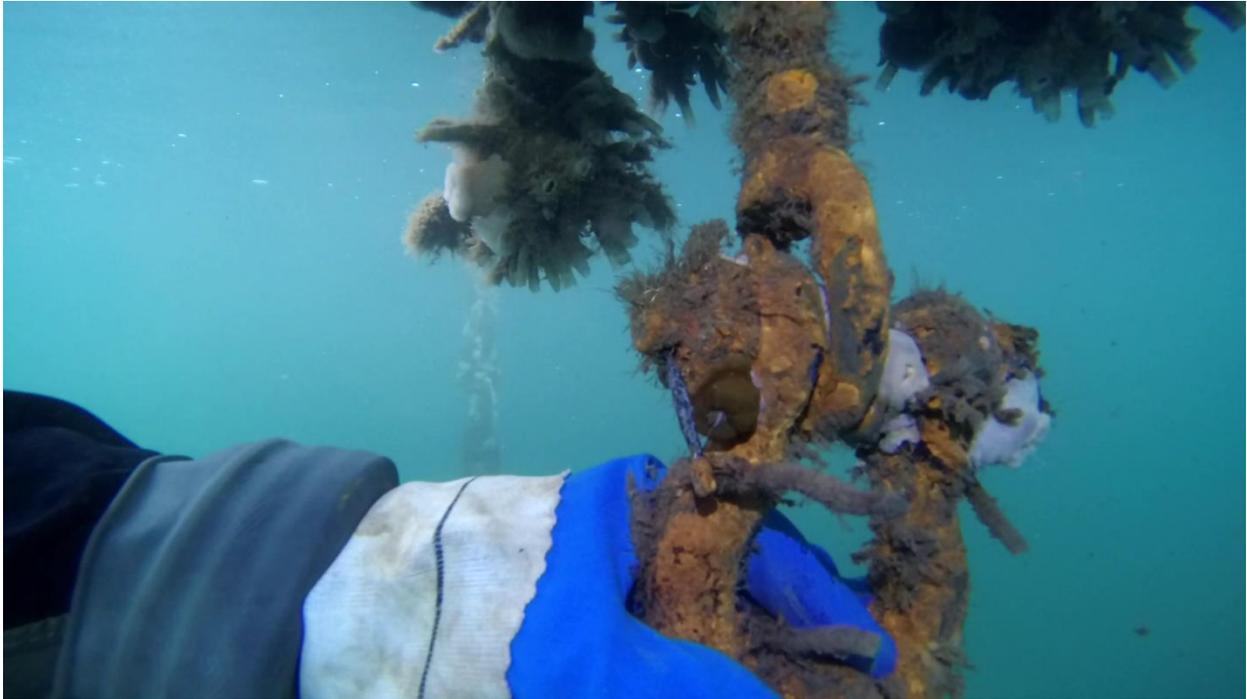
Each mooring buoy has a 54" long x 3/4" threaded rod running through it. At the bottom of each rod is a 5/8" eye nut which the buoy chain attaches to. Below this eye nut there *should* be an additional hex nut to secure the eye nut and prevent it from backing off. The hex nuts on buoys A2 & A3 were missing and it appears the eye nut had backed off. In addition, some of the cotter pins for the shackles were mild or galvanized steel and had corroded away. The biggest concern with the buoys are the threaded rods, they are covered in a thick layer of surface rust & the rods, eye nuts, and shackles are deteriorating. If this continues, the threads could weaken and the eye nuts could eventually fail. An anode installed on the buoy chain, close to the buoy as possible would help prevent further corrosion & deterioration. These rods likely have a service life of less than 3 years. **(See photos 28-30)**

Photo 28: Typical rust & deterioration of buoy rod, eye nut, & hardware. Missing hex nut.

Photo 29: Typical rust & deterioration of buoy rod, eye nut, & hardware. Missing hex nut.

Photo 30: Typical rust & deterioration of buoy rod, eye nut, & hardware. Missing hex nut.

Each mooring float chain needs an anode installed on the buoy chain as soon as possible to prevent further corrosion and failure.
