**INVITATION FOR PROPOSAL #03-24-30028
Bremerton Marina Underwater Inspections**

Addendum 1, 11/13/2024

BREMERTON MARINA BREAKWATER

USS TURNER JOY - MOORING SYSTEM

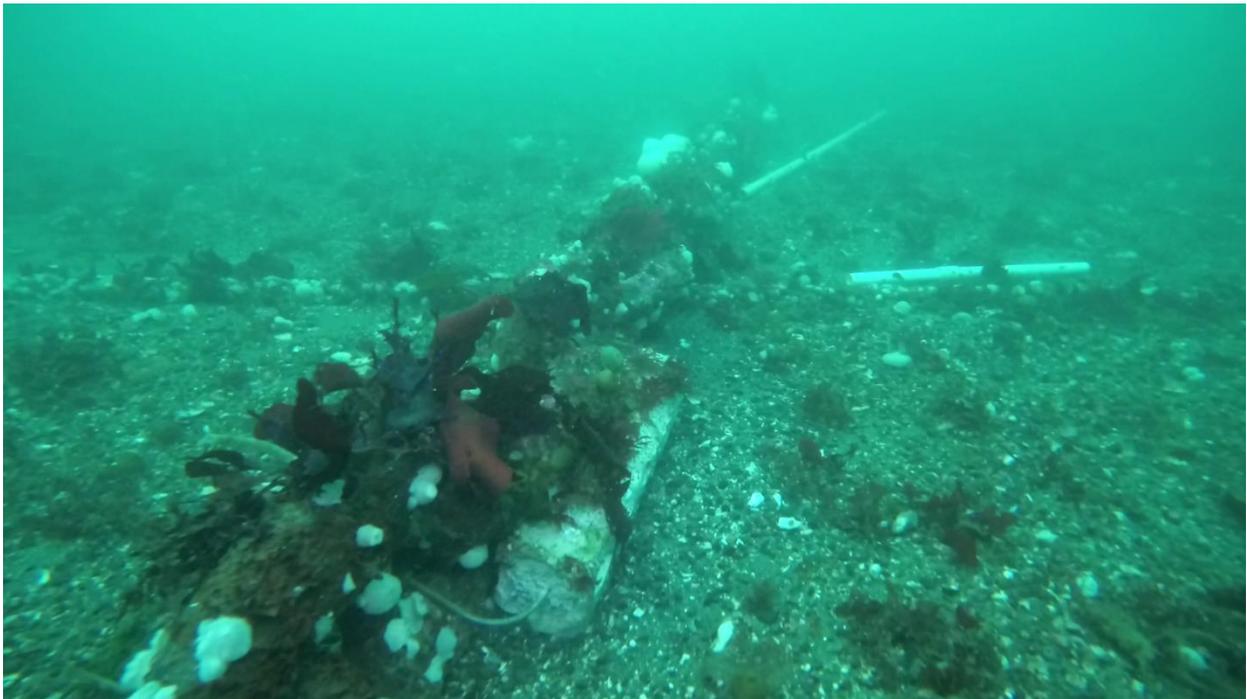
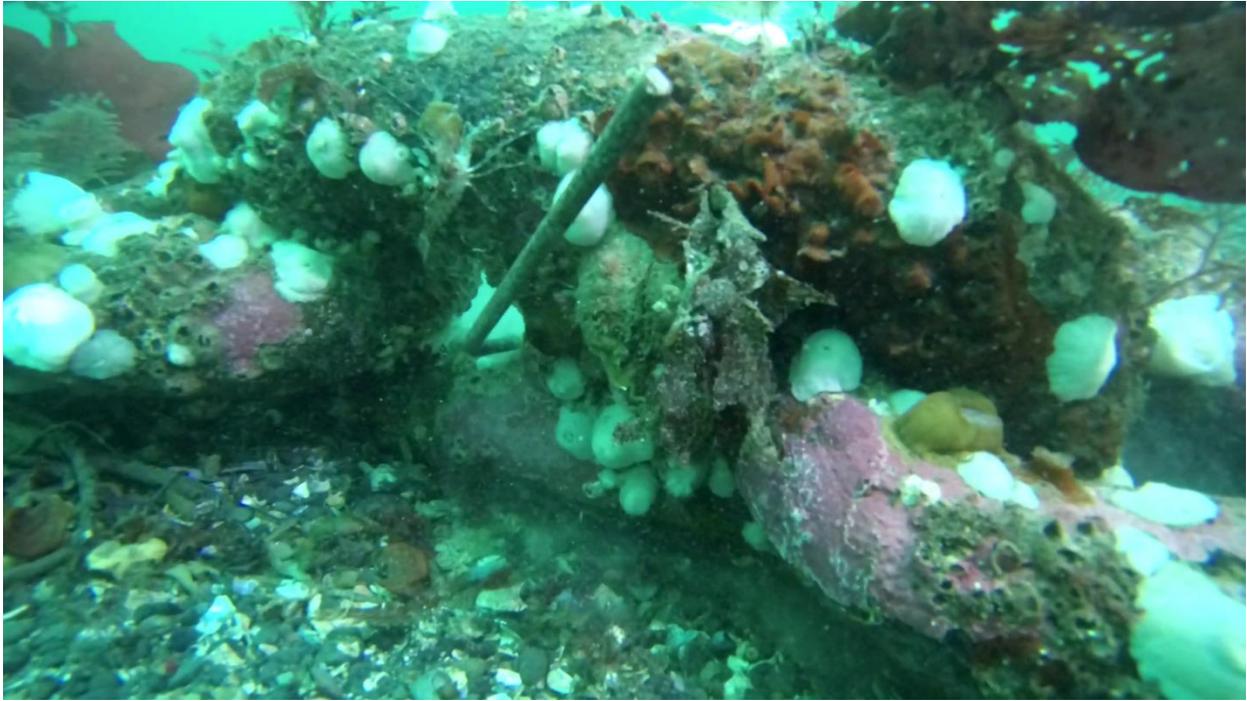
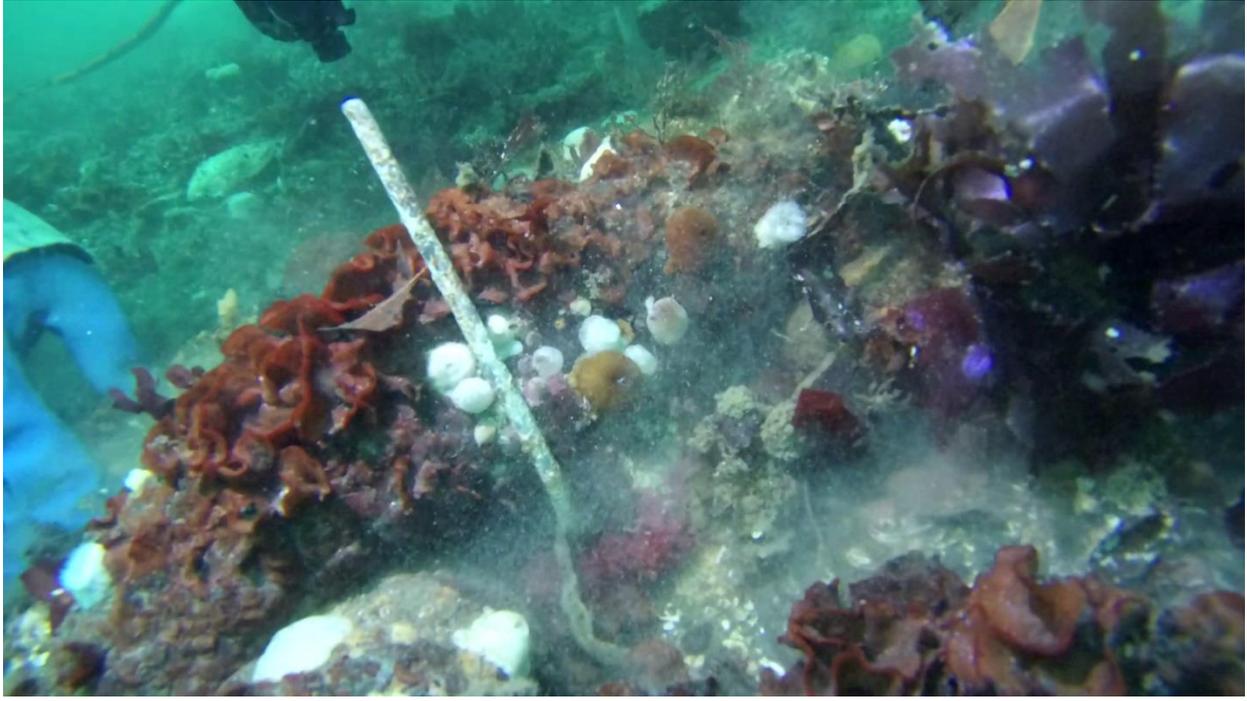
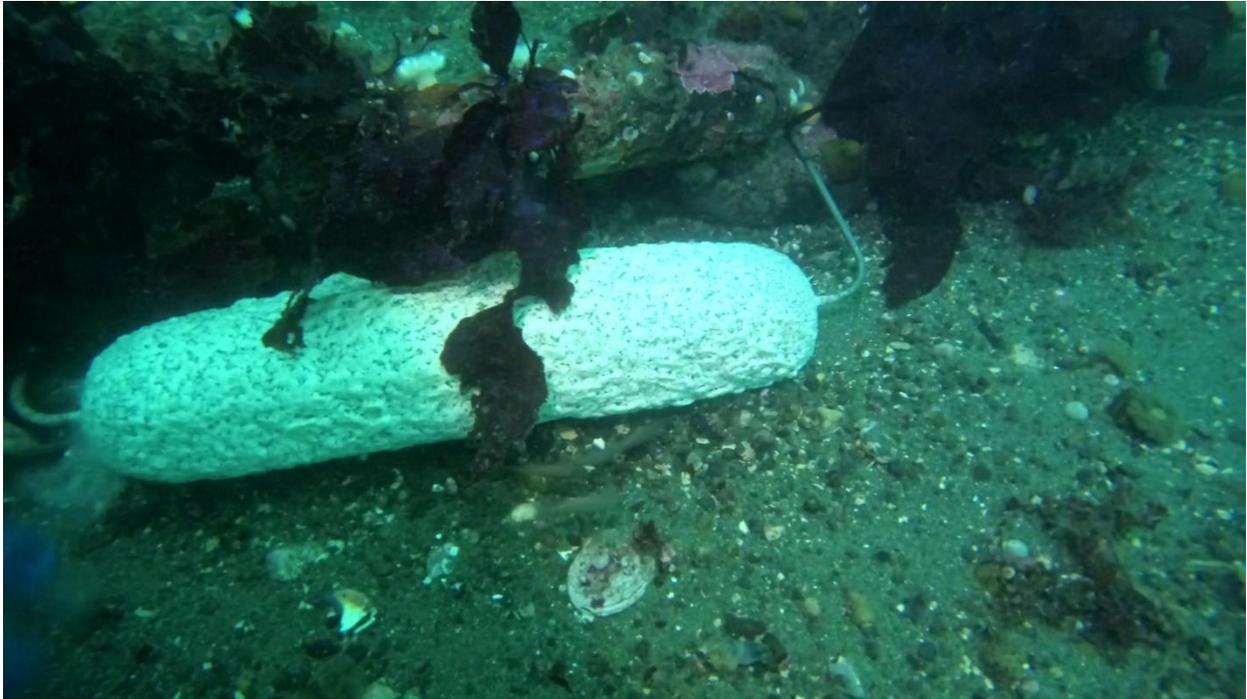
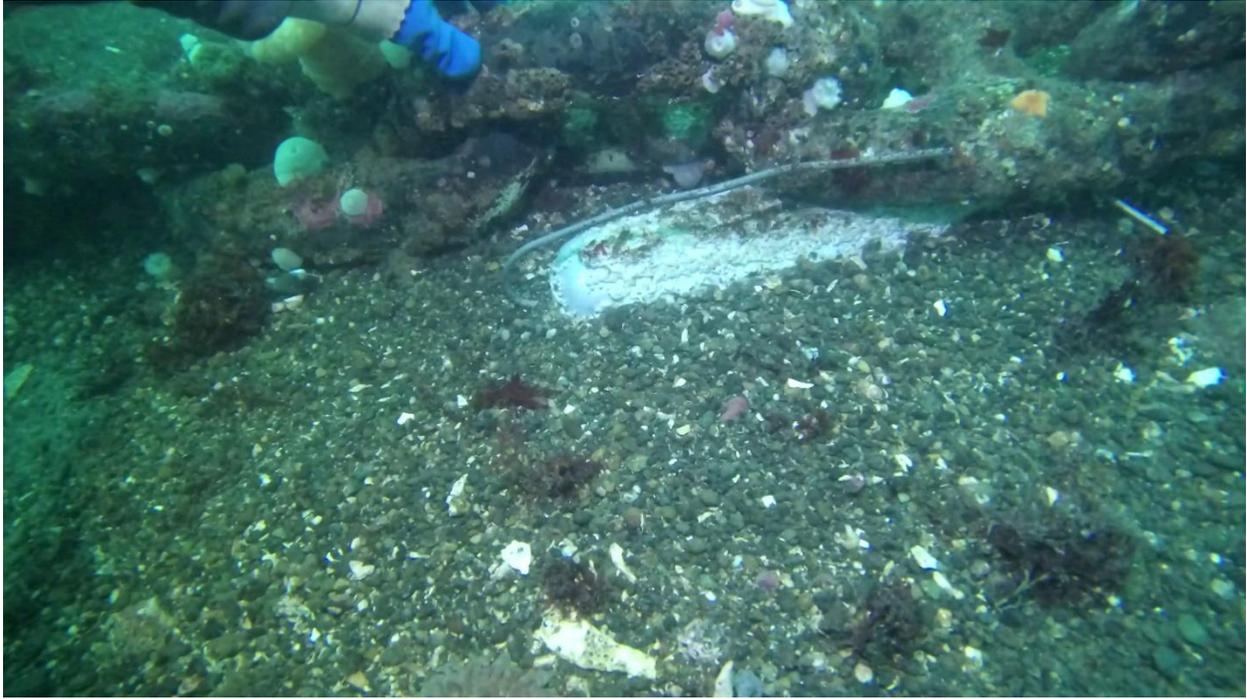
Two rod-type anodes were installed on each anchor chain. One near the upper portion of the anchor chain, and one near the middle of the anchor chain. Each anode has two rods, one extending from each end of the anode. It appears the anchor chain links were not cleaned down to bare metal as there is marine growth as well as a thick corrosion layer on the chain links. The anodes are installed horizontally and with the rods essentially bent at a 90 degree angle and sticking through the chain links making little connection to the chain surface. These rods should wrap around the anchor chain links.

The anodes are ineffective and providing no cathodic protection and there is still visible surface corrosion throughout the anchor chains. The existing anodes can still be used. We recommend cleaning the chain link surface area and reinstalling the anodes, ensuring the rods have a tight wrap & secure connection to the chain links. **(See photos 31-37)**

Photo 31: Typical anchor chain anode condition

Photo 32: Typical anchor chain anode condition

Photo 33: Typical anchor chain anode condition

Photo 34: Typical anchor chain anode condition

Photo 35: Typical anchor chain anode condition

The anchor chain anodes need to be removed, chain links cleaned down to bare metal, and anodes reinstalled properly with rods wrapping the chain links tight & securely. This should be carried out as soon as possible.

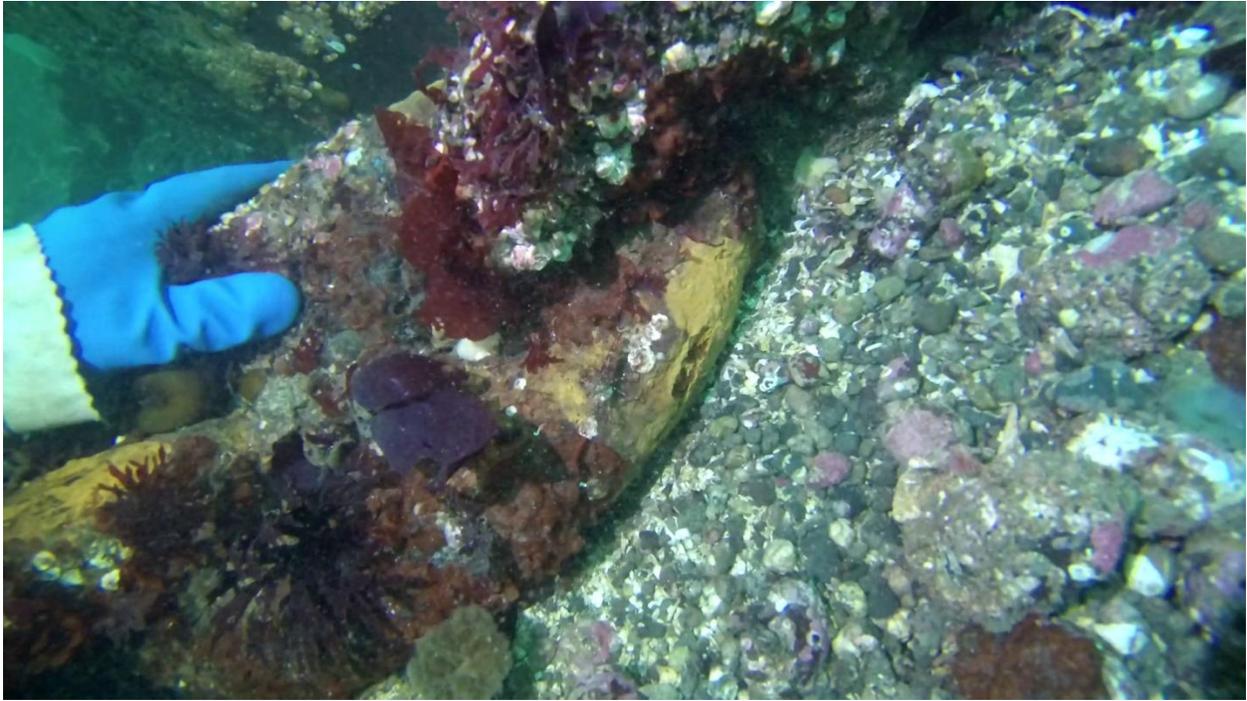
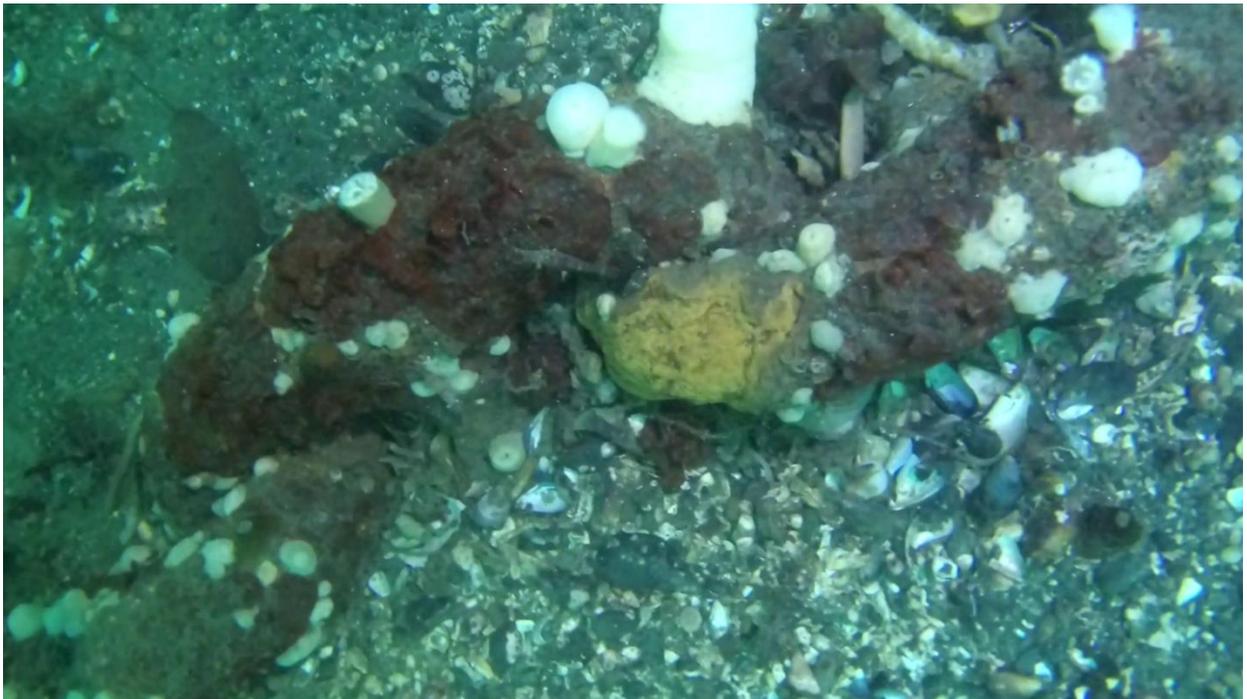
Photo 36: Typical anchor chain surface rust & deterioration

Photo 37: Typical anchor chain surface rust & deterioration
